SafeWork SA – Safety Alert for building owners and managers on millboard lining in heating ducts

Strategy:
Identification

Location:
South Australia

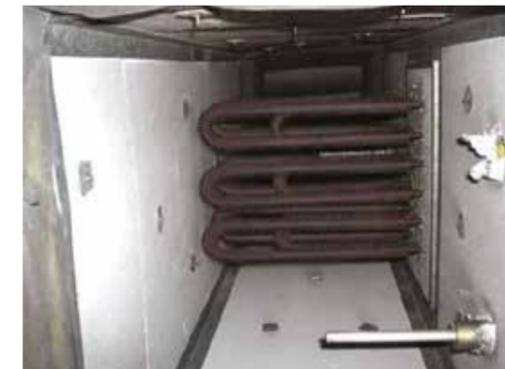
Figure 21: Asbestos lining within a heater bank.

SafeWork SA determined that the millboard lining should be identified as containing asbestos and removed prior to demolition or refurbishment to minimise exposure risks.

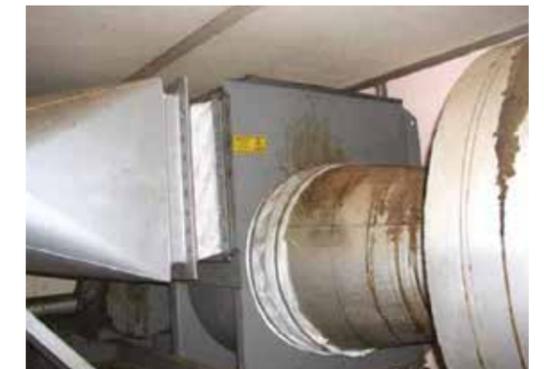
Figure 22: Textile flexible joint in the exhaust duct.
