# ASEA REPORTS

## Case studies of significant asbestos removal projects

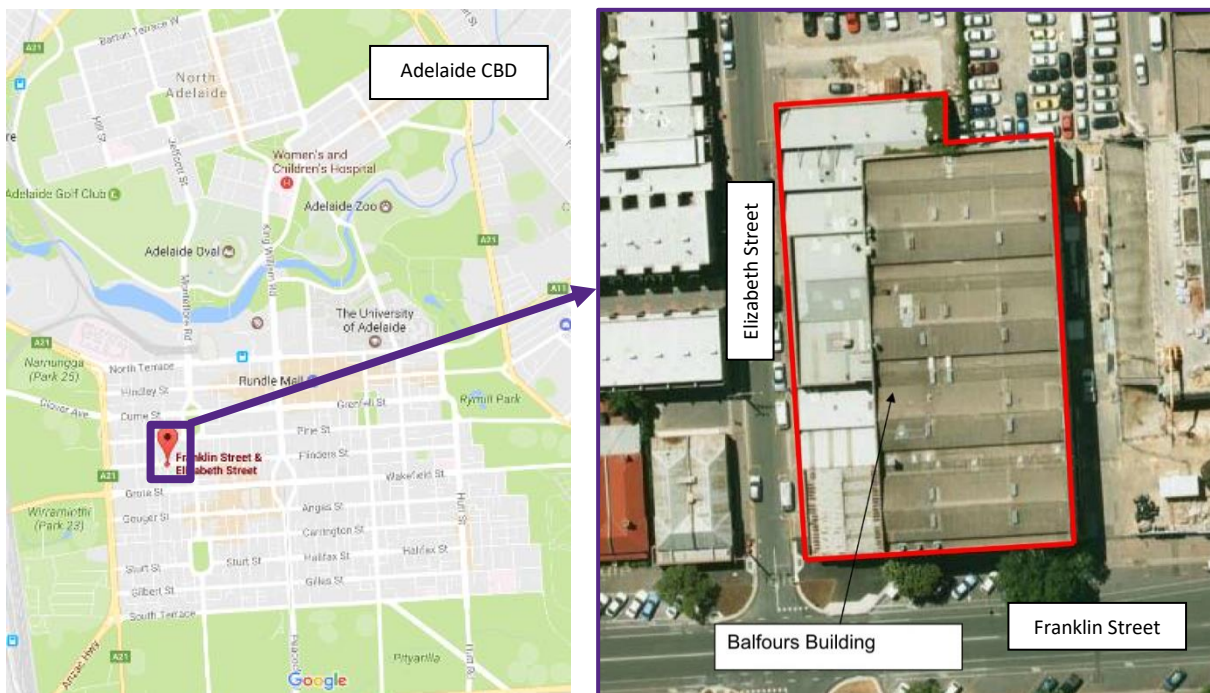
The building was left vacant when Balfours moved to a new facility in Dudley Park, which subsequently led to break-ins and vandalism at the empty site. City of Adelaide staff were often required enter after a break-in to secure the building, and concerns about asbestos and other hazards such as needles were raised at that time. Given the poor and unsafe state of the site (see Figure 1.2 overleaf) as well as the asbestos concerns, the City of Adelaide engaged Carters Asbestos Managers to conduct a site inspection in 2013.

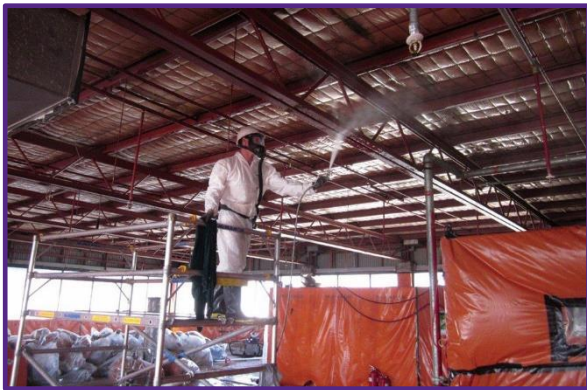
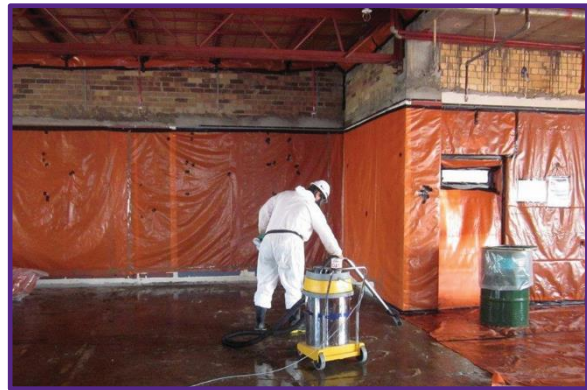
## Project setbacks and challenges

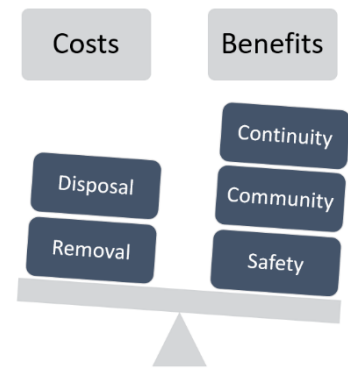
## Management of risks and use of regulations

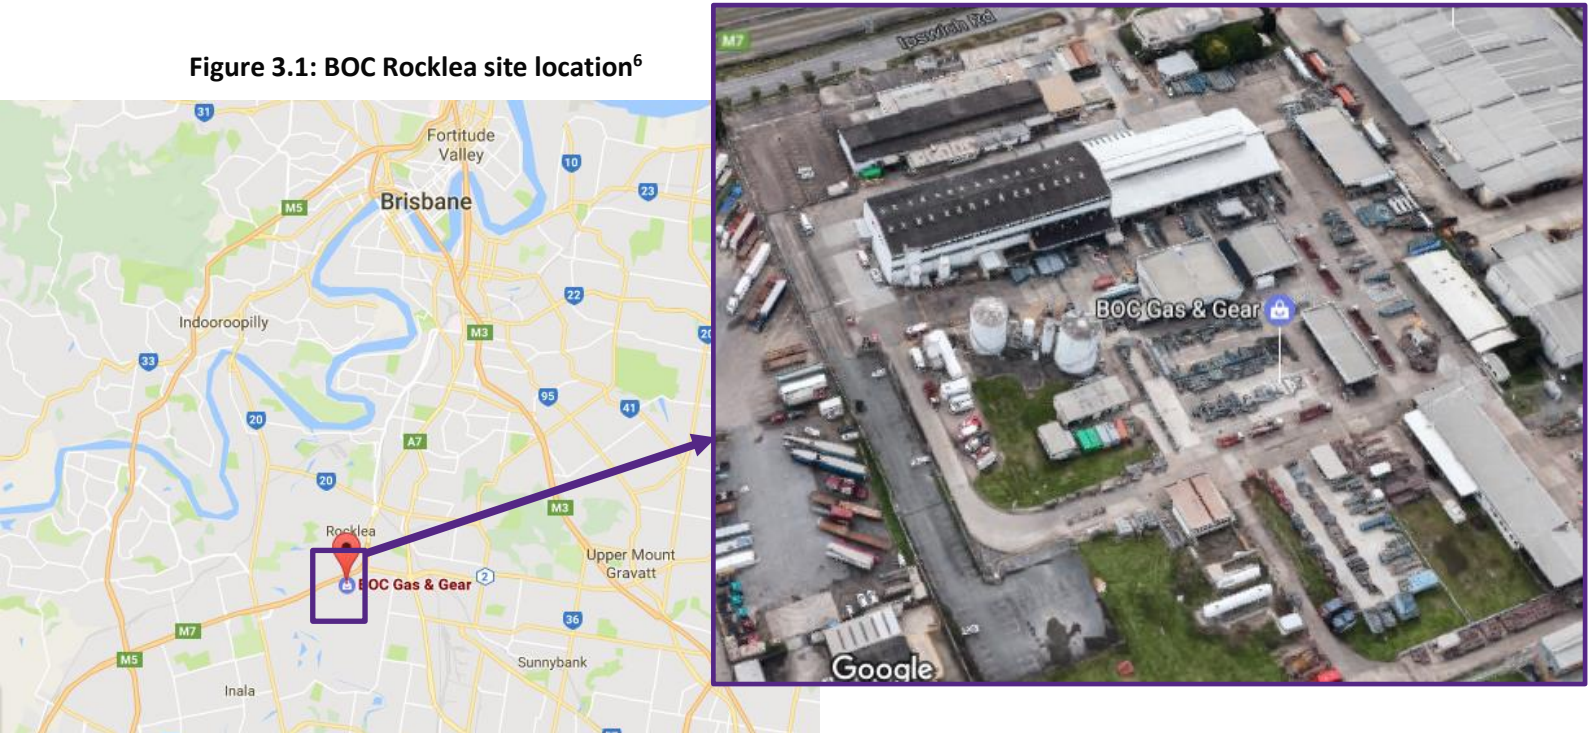
On 27 November 2014, a storm supercell passed across Brisbane and the surrounding region. The storm produced wind gusts of more than 140 kilometres per hour and large hail stones that caused widespread damage and destruction across the city.

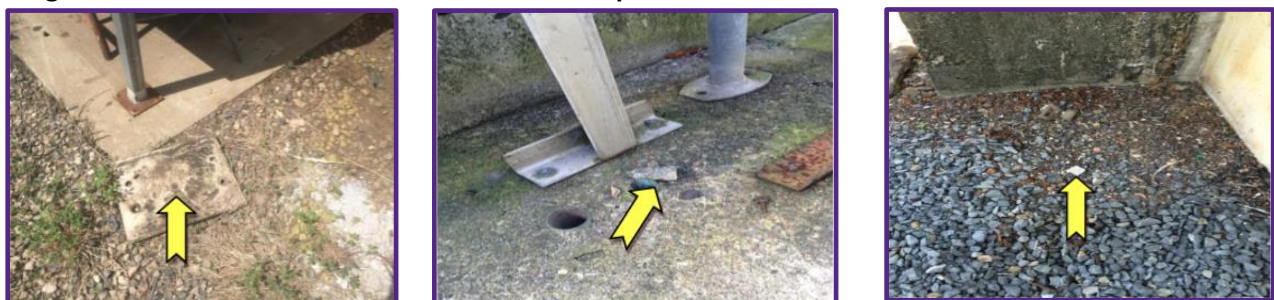
<sup>6</sup> Map data: Google

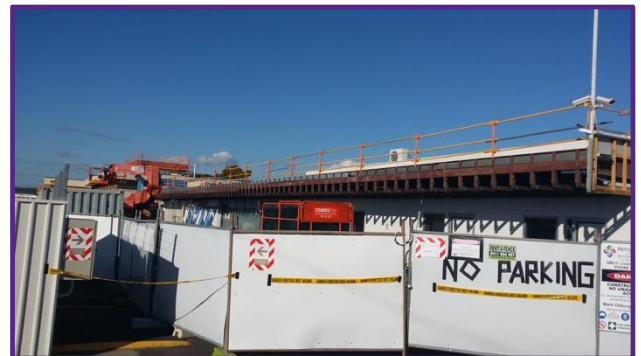
**Figure 3.5: Removal of asbestos sheeting from warehouse**

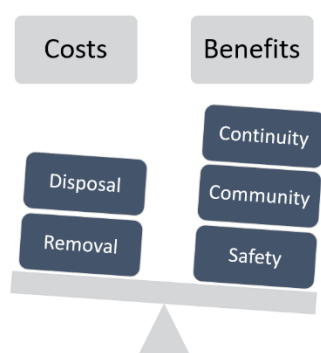
Upon assessment of the damage from the storm, there were a number of options available to BOC, including continuing to manage asbestos in place. This would involve the identification, encapsulation and repair of the damaged sections. A cost benefit analysis illustrated the difficulty in finding suitable materials to patch and repair the Super 6 sheets and that the long-term problem of safely managing asbestos would not go away, particularly when the likelihood of further storm damage was considered.

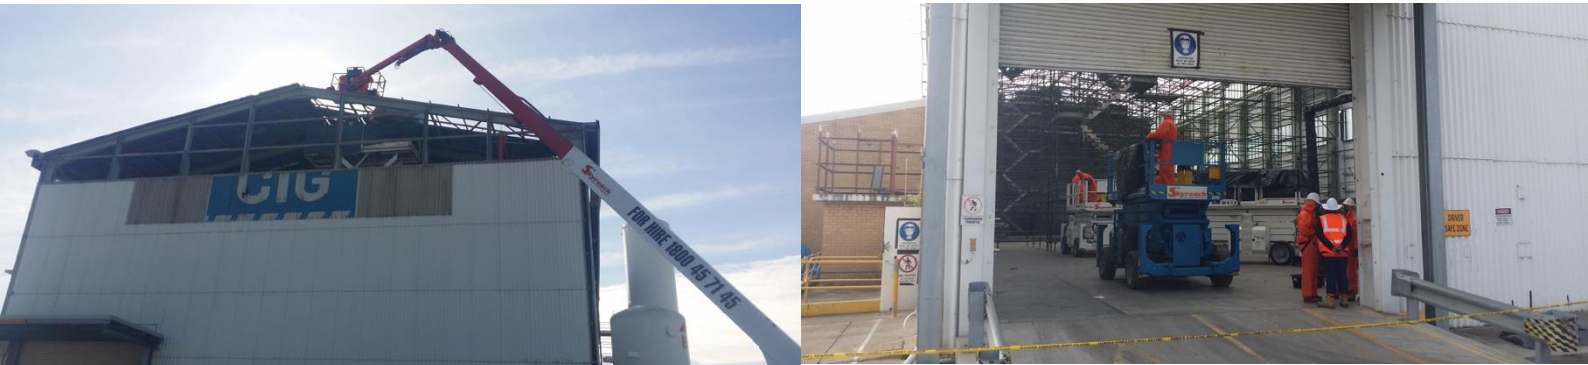
One key stakeholder was a neighbouring site where some asbestos removal was undertaken near the fence line of the site boundary. In some areas, part of the scaffolding and an Elevated Work Platform needed to use the neighbouring site's grounds. Other stakeholders included unions, Workplace Health and Safety Queensland, BOC's insurance company, retail customers and BOC's global offices.

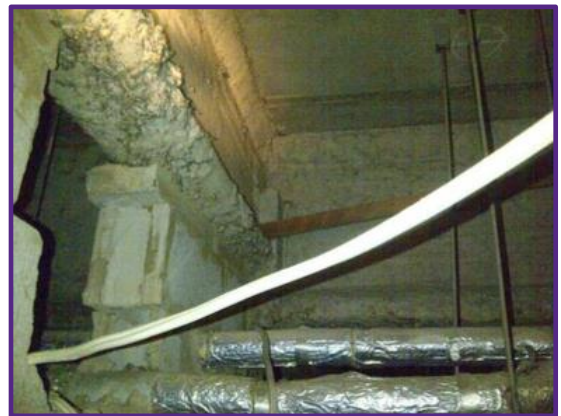
Once a successful tenderer was selected, the extent of asbestos contamination meant that considerable project planning and consultation was required amongst all parties. WorkSafe Victoria were involved from the outset in developing an acceptable Asbestos Removal Management Plan and were cooperative and instrumental in establishing methodologies and procedures for how asbestos would be removed, how the site would be protected and what air monitoring would be required.

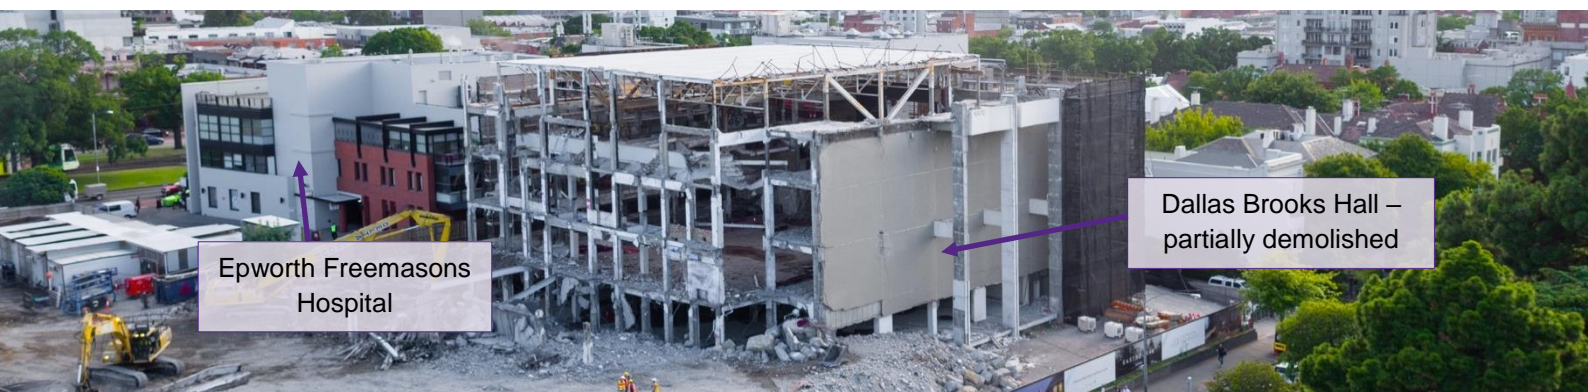
## Asbestos removal program

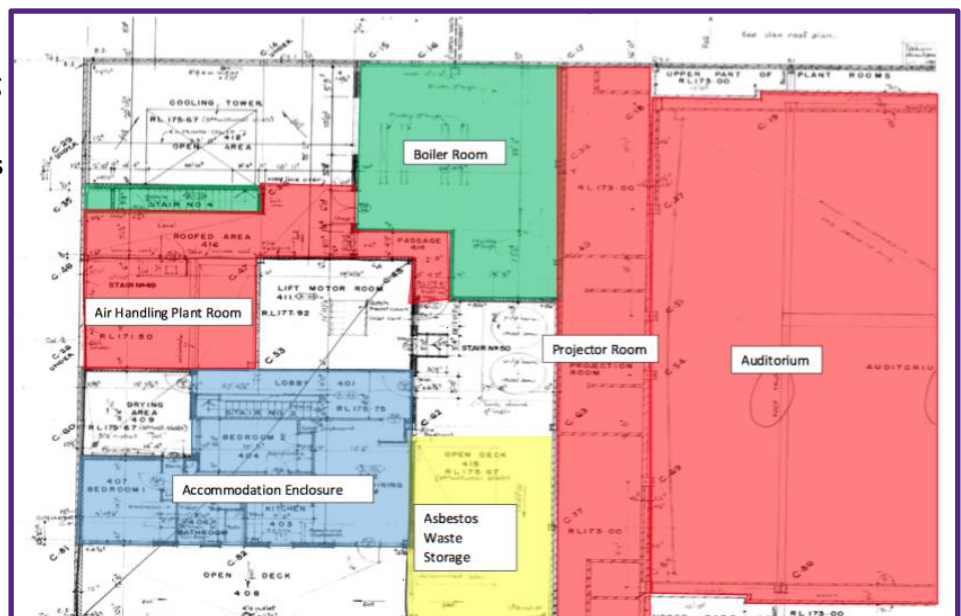
## Removal methodology

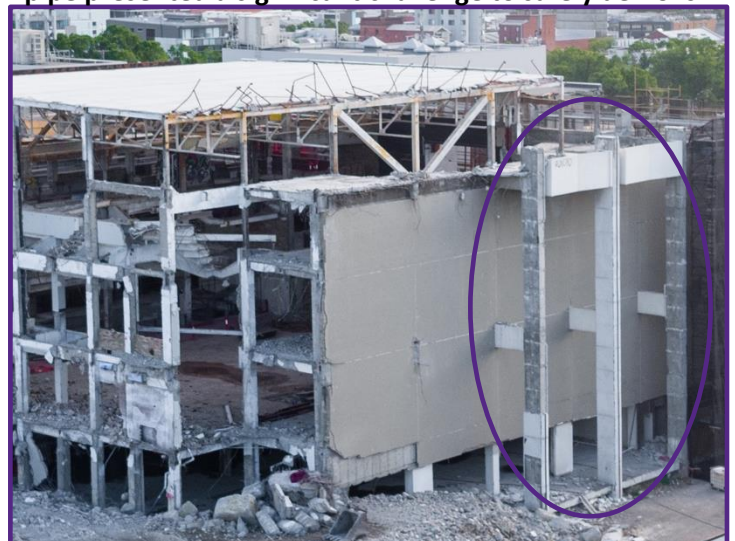
Where the columns were located too close to the hospital, a variation on this procedure was devised. This involved holding the top of the column, cutting it at the bottom and then lifting it to a more central area on the site for destruction.

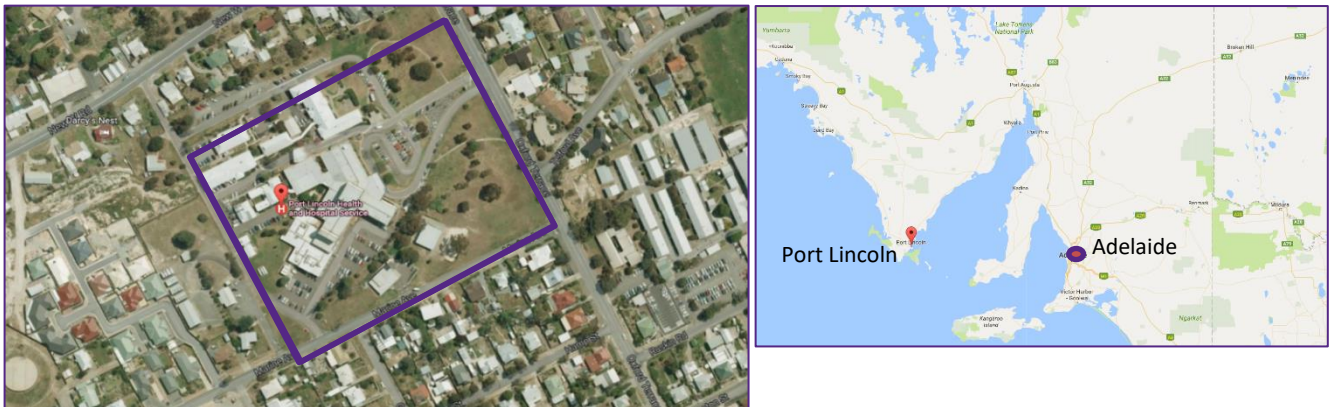
## Site sampling, assessment and project planning

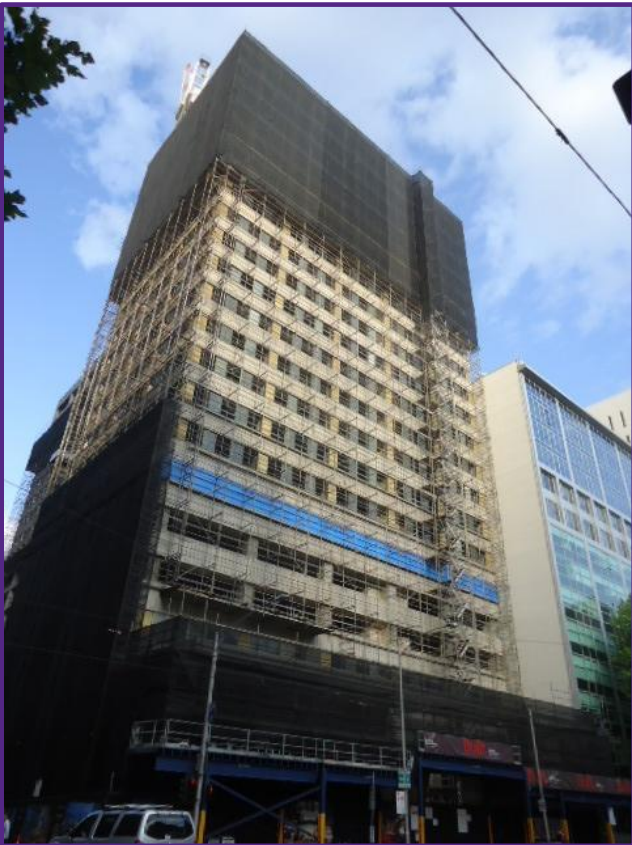
Asbestos was found in a large range of materials located throughout the building, including:

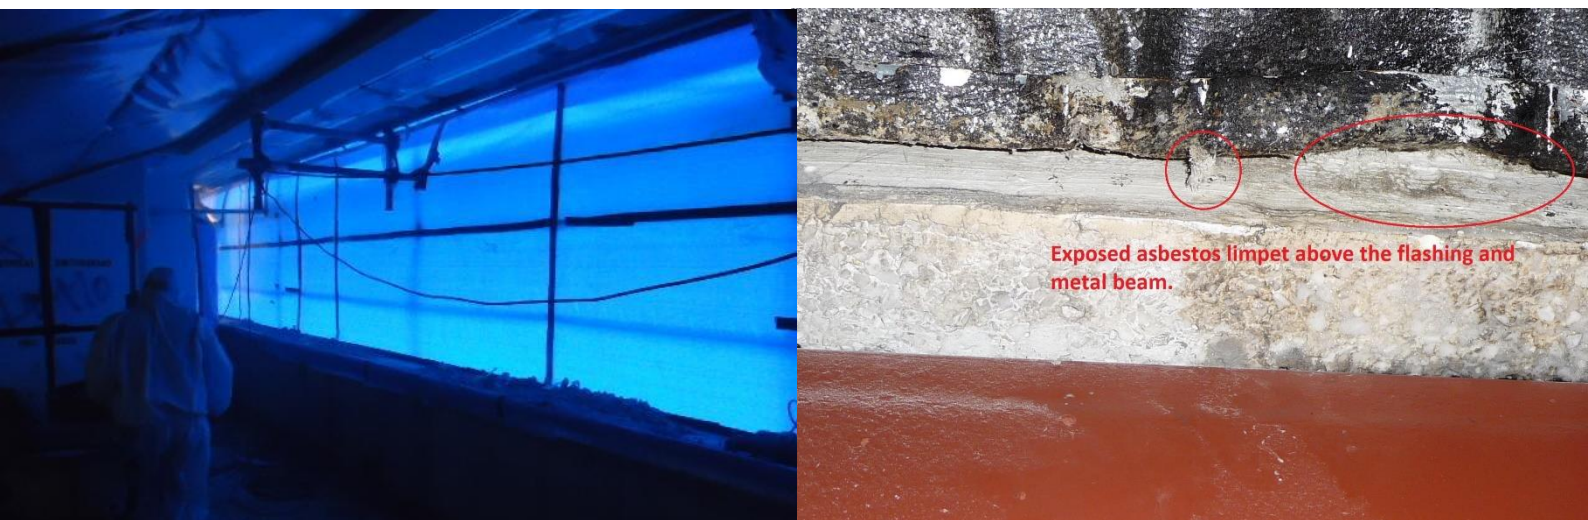
A bubble enclosure was used around this work and because the panels were located on the façade of the building the enclosure need to extend out on to the scaffolding on the outside of the building.

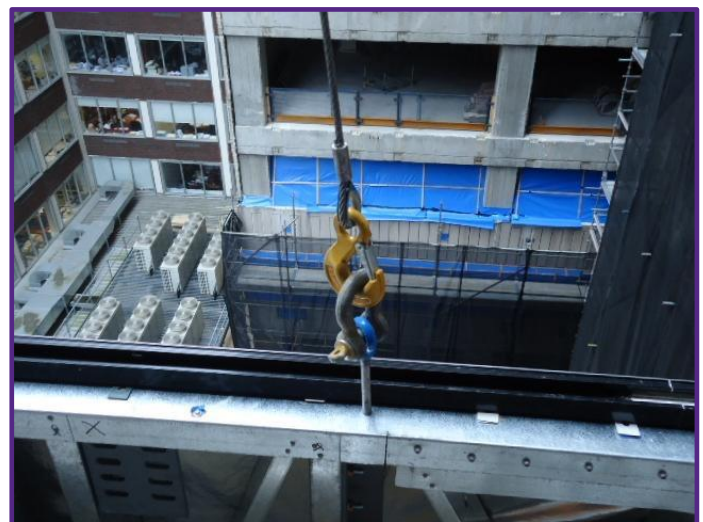
The ongoing management of sensitive stakeholders was another key consideration in this project. There were 200 workers on the job during the asbestos removal phase and all needed clear communication on the risk management processes. Air monitoring results were reported and displayed daily and there were weekly toolbox sessions. Contractors kept up to date with asbestos locations and exclusion zones through the Permit to Work process. WorkSafe Victoria was consulted on the asbestos removal methods, particularly in relation to the concrete infill material on the spandrel panels. Neighbouring building occupants were also communicated to on a regular basis, starting with 4 major sessions for a broad range of stakeholders and then weekly updates on progress and reporting of air monitoring results to the facilities managers.

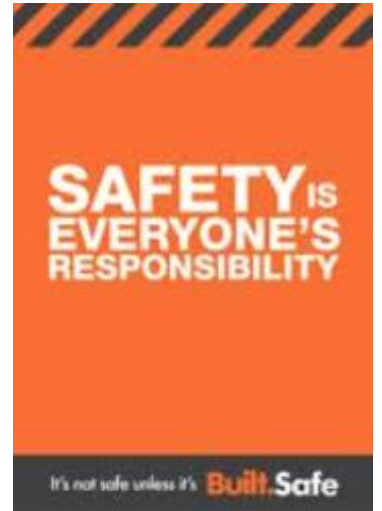
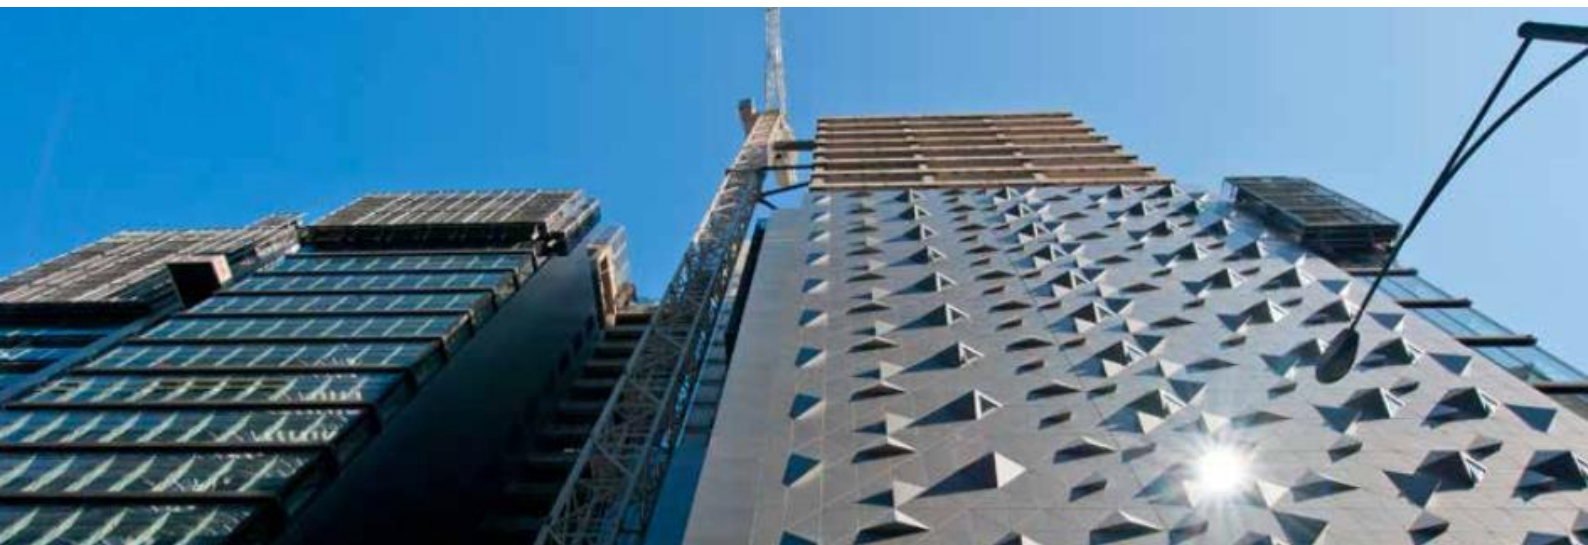
# Laboratory Upgrades, The University of Melbourne

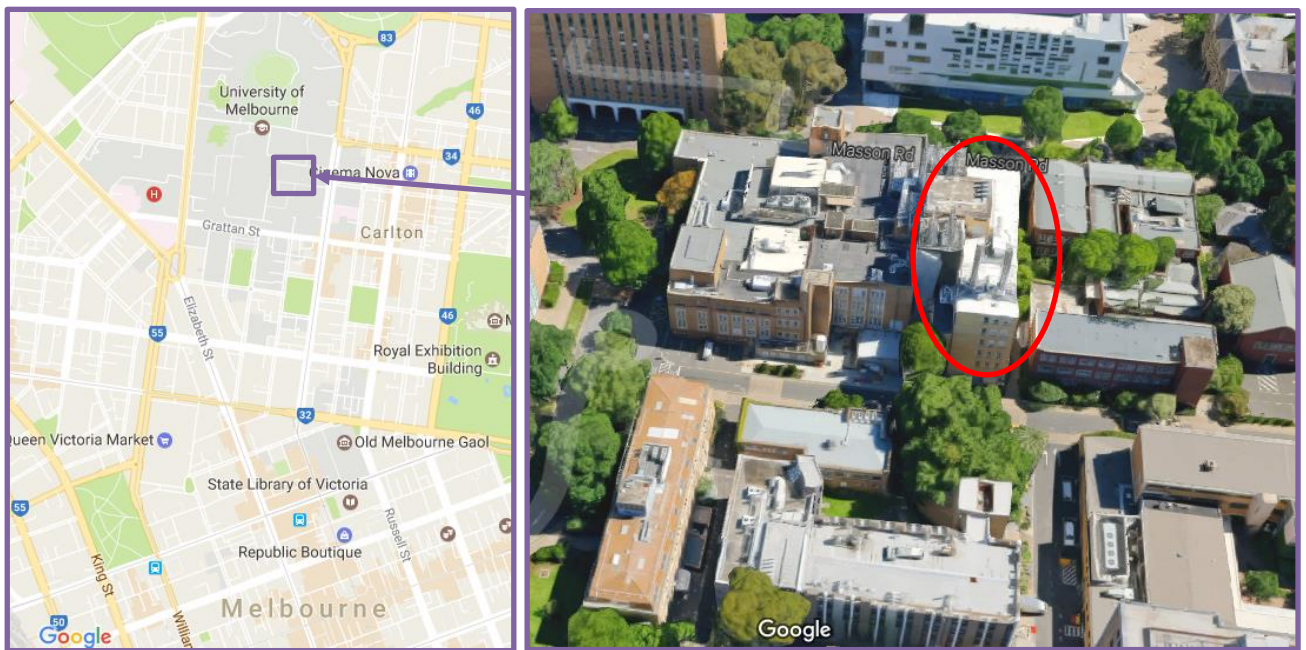
UoM had undertaken in-situ asbestos surveys over several years, including university-wide programs completed in 2007-2008 and 2013-2014. Labelling was applied directly on or adjacent to ACMs (see Figure 7.2 for an example), at the entrance to work areas and on site plans. All asbestos was included in the University's Hazardous Materials Register.

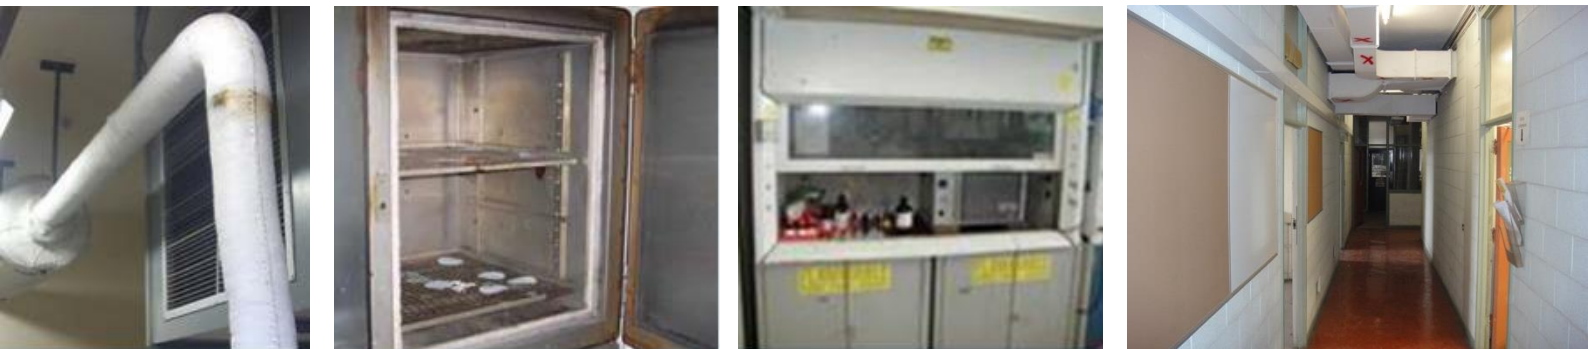
As a tertiary education provider, UoM is sensitive to public concerns about asbestos exposure and chooses to directly manage asbestos removal with a project manager rather than to delegate this responsibility to a builder. This allows UoM to manage the process effectively and to ensure communications are managed in accordance with internal policies and objectives.

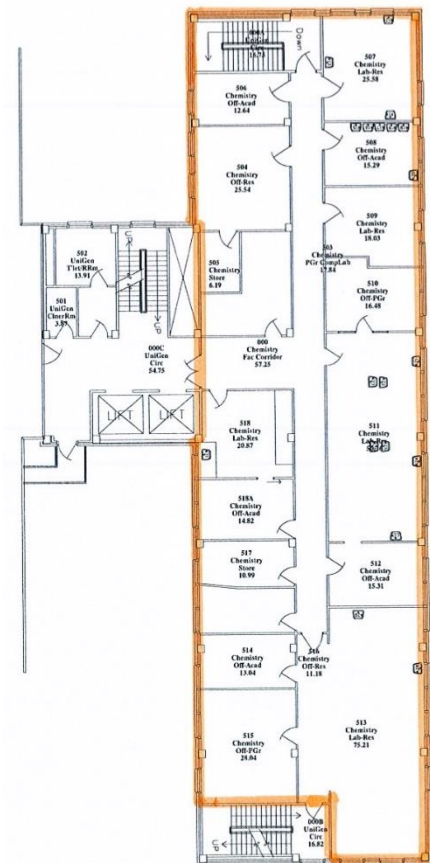
Another risk area that was carefully managed was the isolation of mechanical services. Asbestos was found in the mastic used in the flanges between sections of steel ducting in the ventilation services. A mechanical services contractor was used to fully isolate each section of the system by cutting and sealing duct sections elsewhere within the building to allow other floors outside the removal area to remain operational. The contractor could then work on the affected area by cutting around the flange and taking out the whole duct join for disposal as asbestos contaminated waste.

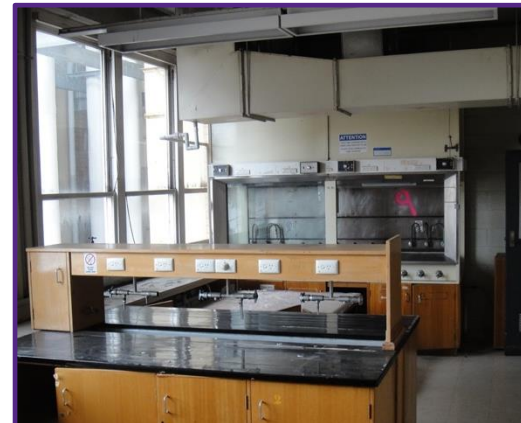
## Innovation and excellence

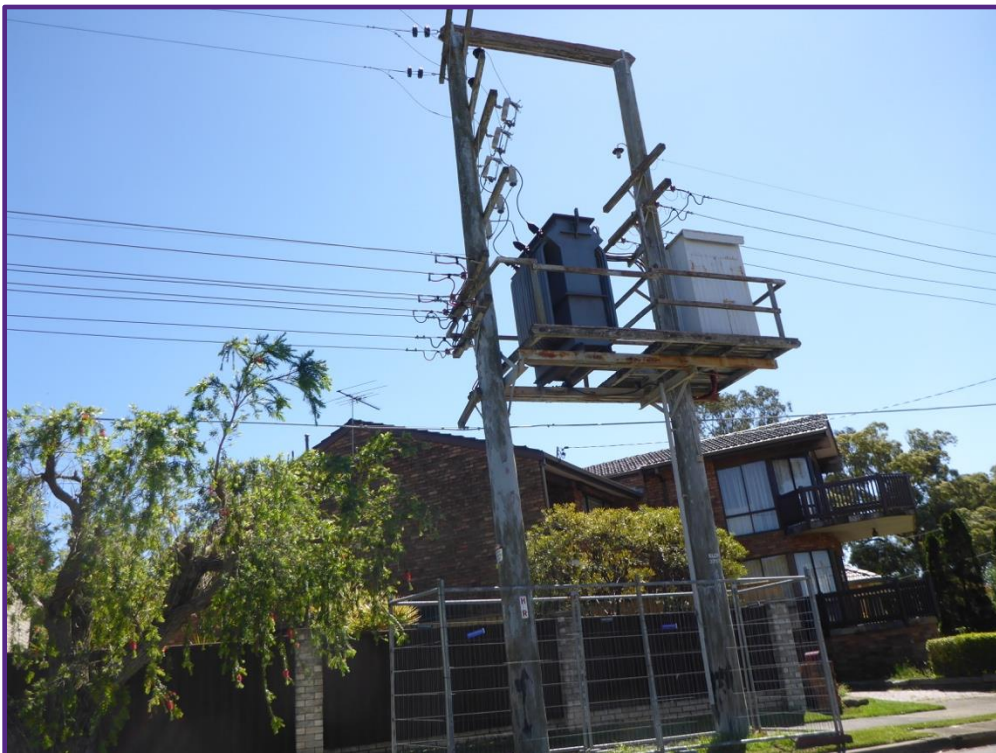
Ausgrid published the first of multiple safety alerts advising workers of the presence of friable asbestos-containing paint on these substations in the St. George region. All planned work on poles identified as having remnants of a painted finish was prohibited and network outage and critical operations were only to occur using Level 3 – Emergency Response PPE. Ausgrid also updated its Asbestos Register, GIS and SAP systems.

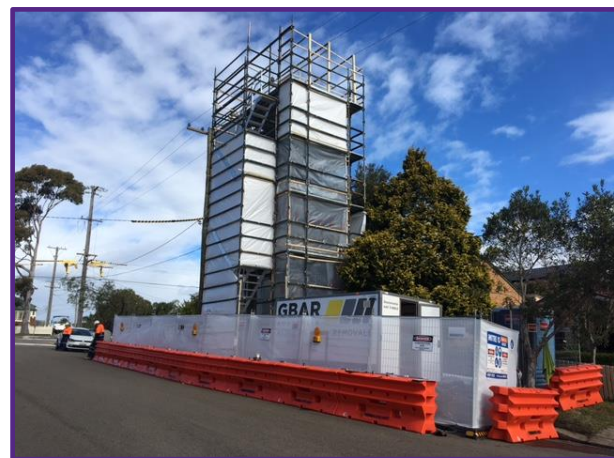
Figure 8.4: Removal Method 2

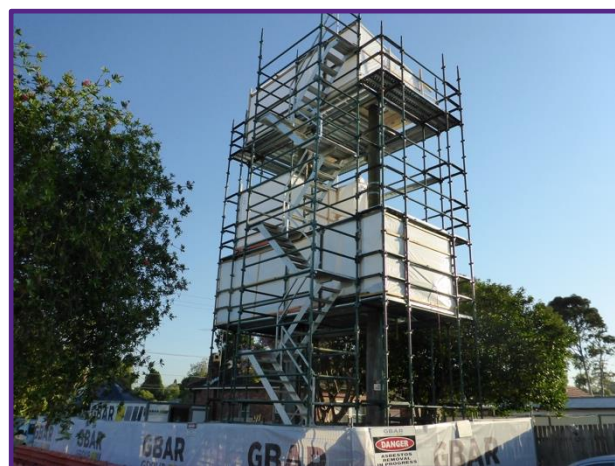
5. Once all loose and flaking asbestos paint has been removed, an area of at least 0.2 m of paint around the radius of the pole removed from the surface of the timber to allow for the cutting of the pole;
6. Assessor conducts a visual clearance inspection for the surface where the pole is to be cut;
7. Once visual clearance is achieved, remaining surface area of the pole encapsulated with Emerclad or similar, and wrapped in 200um thick plastic sheeting at a minimum of 2 times around the pole;
8. The encapsulation is visually cleared by the Assessor and the Removalist cuts the pole, utilising dust suppression techniques with a low-pressure mist water spray;
9. Pole segments placed in skip lined with 200um thick plastic sheeting and disposed of as asbestos waste.

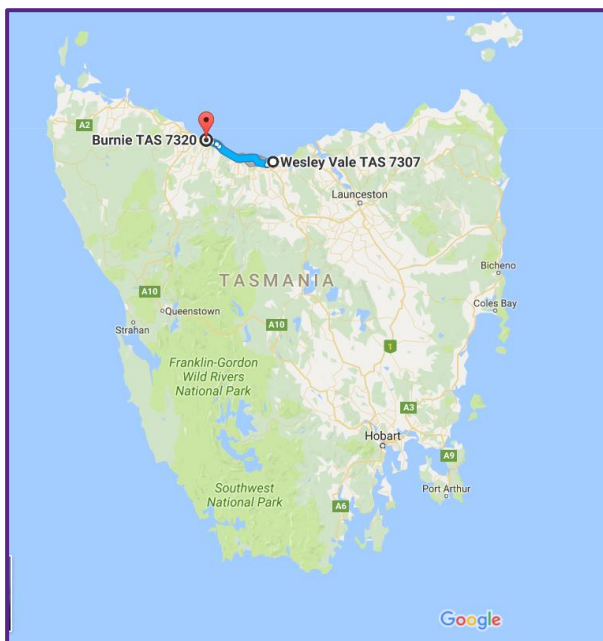
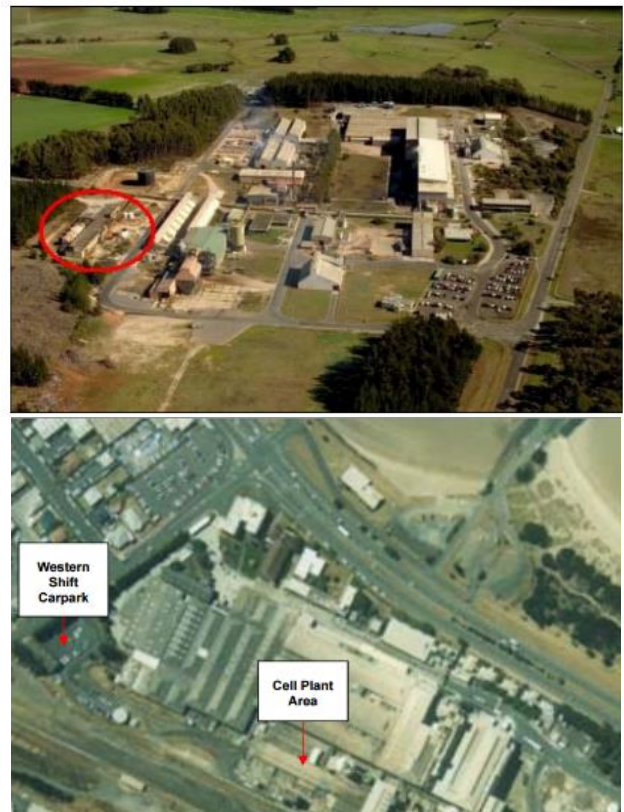
<sup>15</sup>Map data: Google

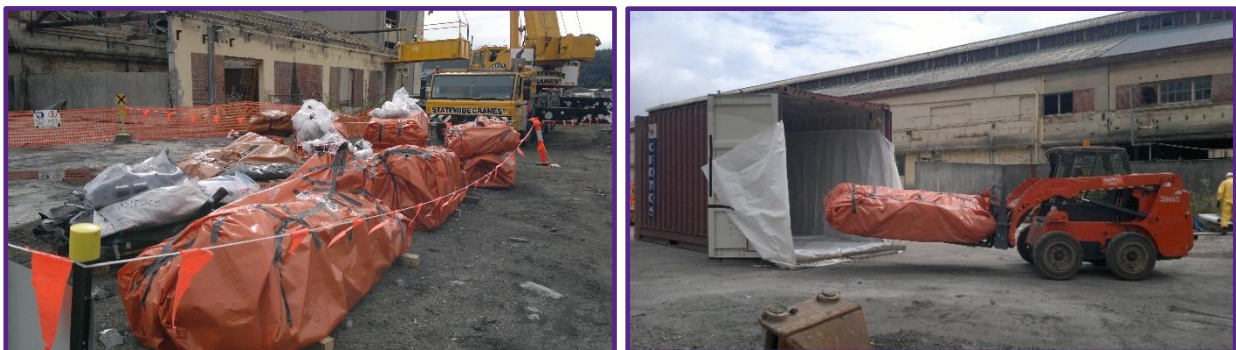
Following the Wesley Vale decontamination and demolition project, contractors moved to the Burnie site, which was a much larger job. The contractors decommissioned and demolished over 50 buildings at this site, many of which had significant volumes of asbestos. Notably, the Cell Plant area contained roofing materials with bonded asbestos, and other areas had soils with varying degrees of contamination.

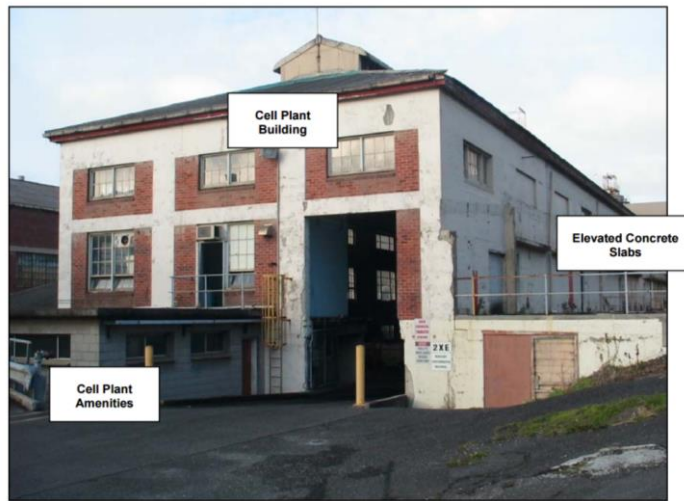
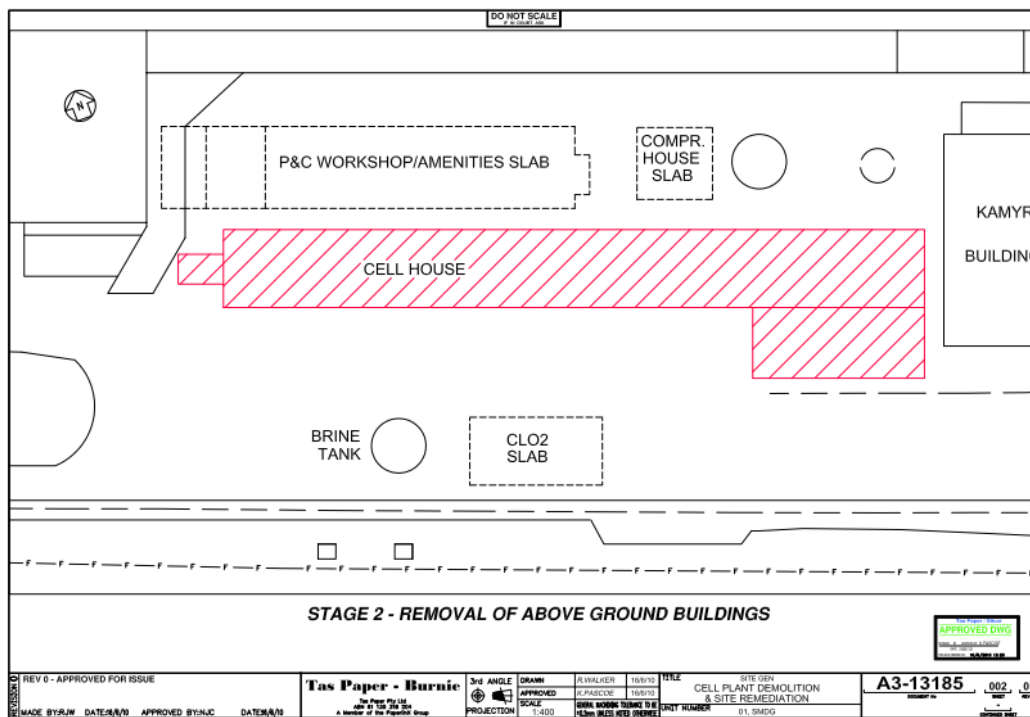
Removal of asbestos roof sheeting at height posed challenges in terms of access and planning. McMahon Services used a crane to hoist a team of removalists onto the roof (see Figure 9.4) to enable safe and successful removal of these roof materials.

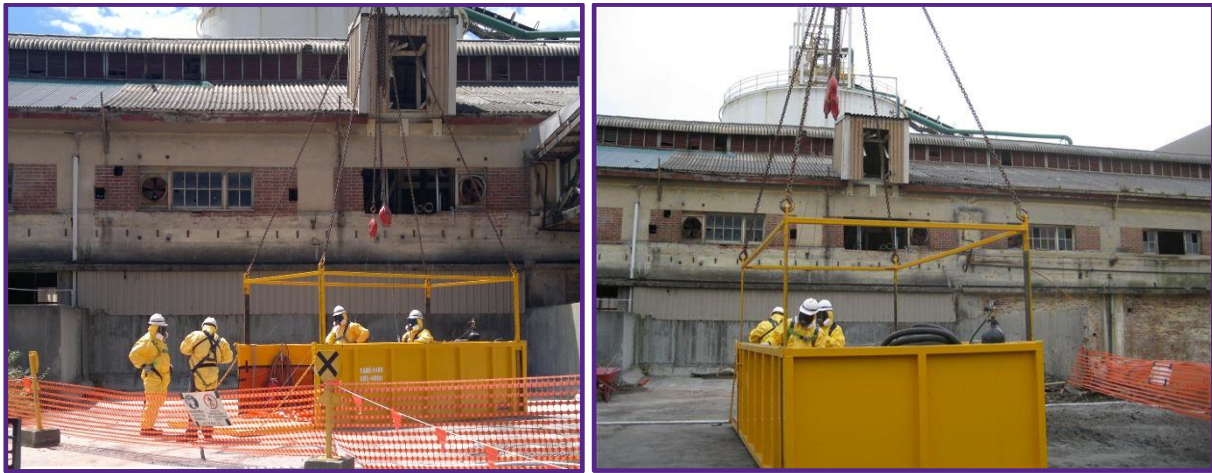
Supporting the asbestos removal process was a rigorous approach to occupational hygiene during the cell plant demolition. The presence of mercury necessitated additional measures which included blood tests, requirements for workers to be clean shaven, a ban on fish consumption during the removal period and a precise decontamination process for crews suiting up and existing the cell plant.

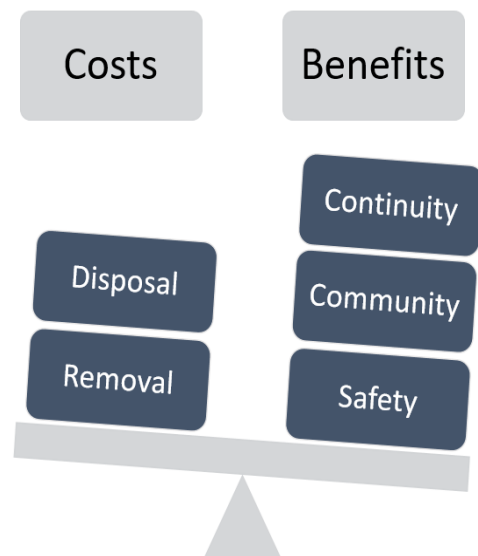
## Management of risks and use of regulations

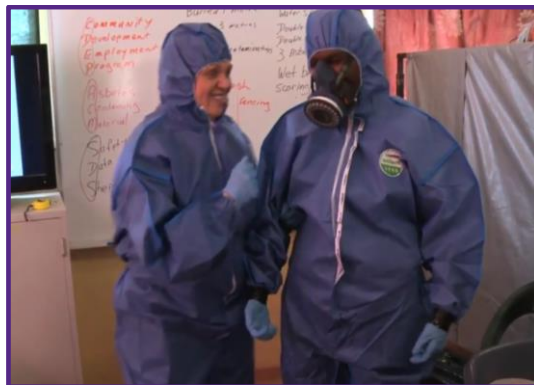
#### 4. Hygienist inspection

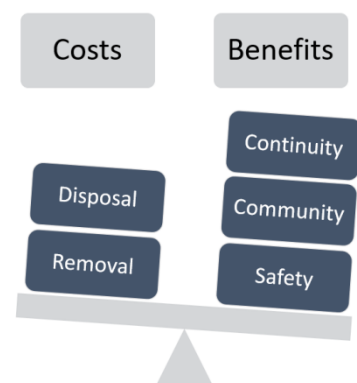
## Management of risks and use of regulations

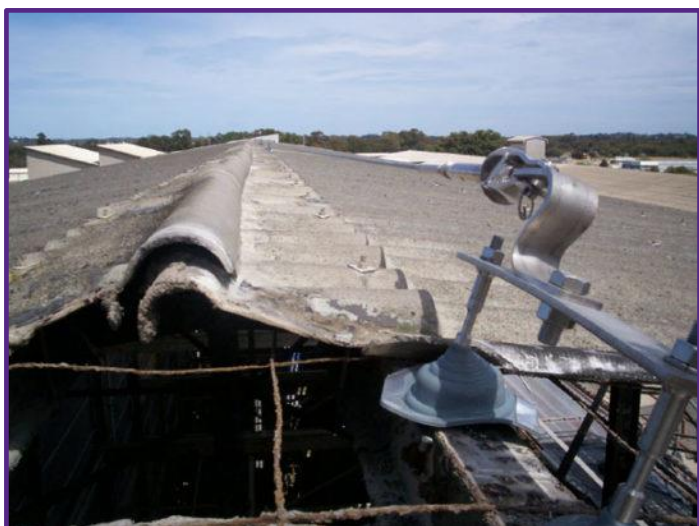
## Innovation and excellence
