ASEA REPORTS

Measurement of asbestos
fibre release during removal
works in a variety of DIY scenarios

MONASH
University

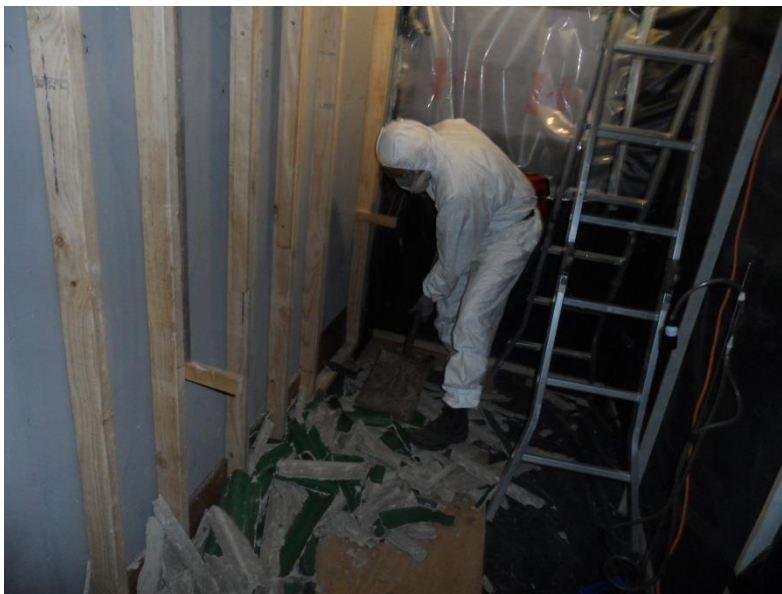
The purpose built enclosure or “bubble” was constructed on the days leading up to the simulation measurements. It was specifically designed to simulate the approximate size of a small bathroom or laundry in a 1960s constructed house. The enclosure (pictured below in Fig 1) had the dimensions 3.6m length, 1.35m in width and 2.6m in height with total volume of 12.7m³. No mechanical extraction was used and it was not under negative pressure.

Figure 1 Enclosure used for simulation tasks

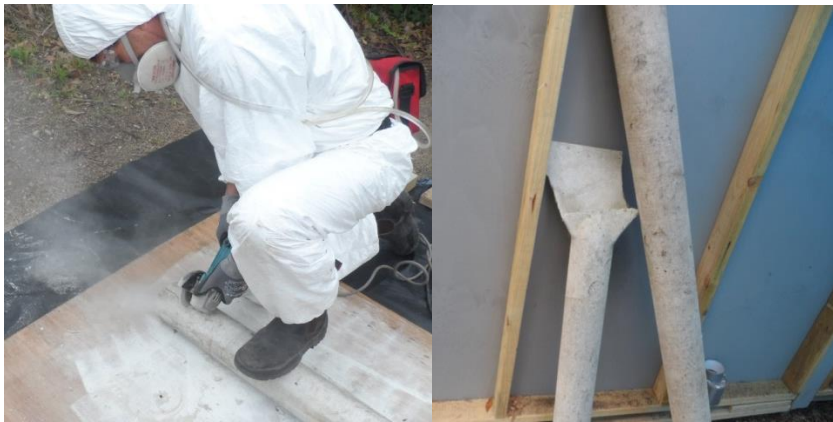
Cutting asbestos cement flue (three cuts) with a Makita-brand 100mmgrinder fitted with an abrasive disk.(see Figures 2and 3).Cutting a 100 mm circular penetration for a flue in corrugated roof sheeting with a drill mounted hole saw. The cutting was carried out outside with a breeze of about 5 to 10 kilometres per hour. The static sampler was located within 2 metres of the worker undertaking the task. The flue cutting was completed in two minutes.

Figure 2- AC Flues

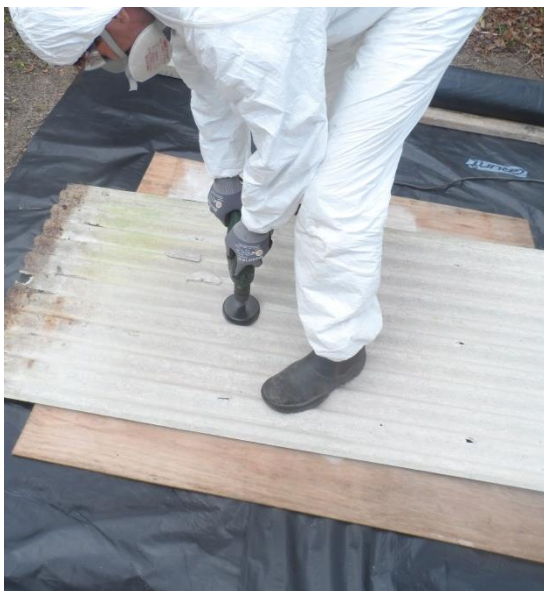
Figure 3 Flue Penetration in AC Sheeting

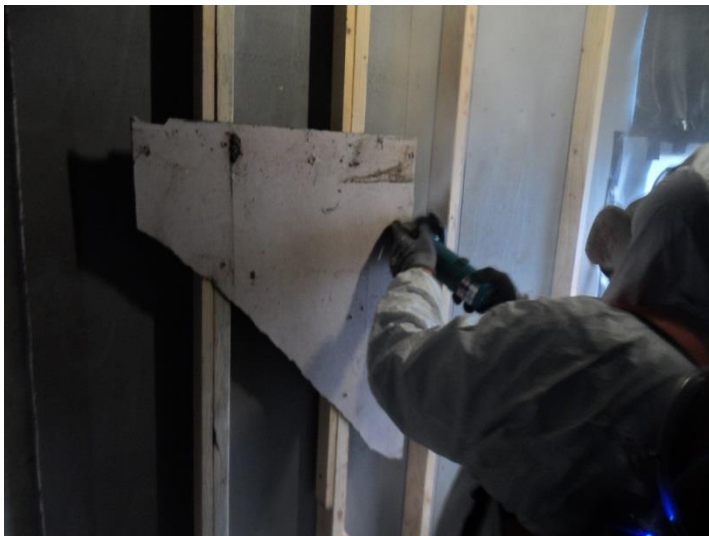
Cutting of penetrations into AC sheeting fixed to a vertical frame inside the enclosure using a Makita-brand angle grinder fitted with a 100mm abrasive disc. Cuts totalled about 1.5 metres in length (see Figure 4). The static sampler was located within 1.5 metres of the worker undertaking the task.

Figure 4- Cutting AC sheeting

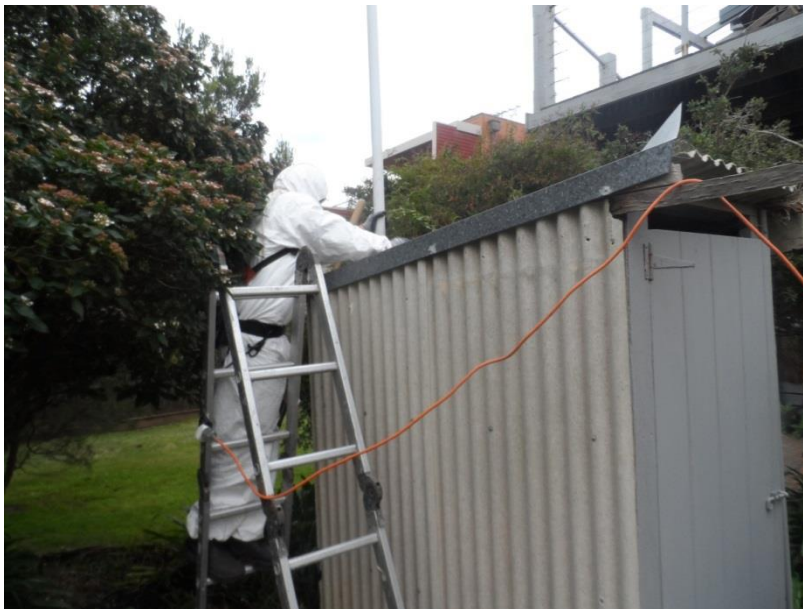
Removal of approximately 6.3 square metres of wall and roof sheeting fixed to a timber framed outdoor shed with minimum breakage of the AC (see Figure 5). Removal of fixing nails by hammer and pinch bar or by breaking surrounding sheet where nailheads were missing, breaking of sheets around plumbing fixtures to enable removal, stacking and wrapping of sheets as they were removed. Debris was cleaned and swept up dry and bagged after removal.

Figure 5- Removal of Asbestos Sheetting from small shed
