Best Practice in Asbestos Management **CASE STUDY 5**

Thuroona Services –
A Complex Removal Process

THUROONA SERVICES – A COMPLEX REMOVAL PROCESS

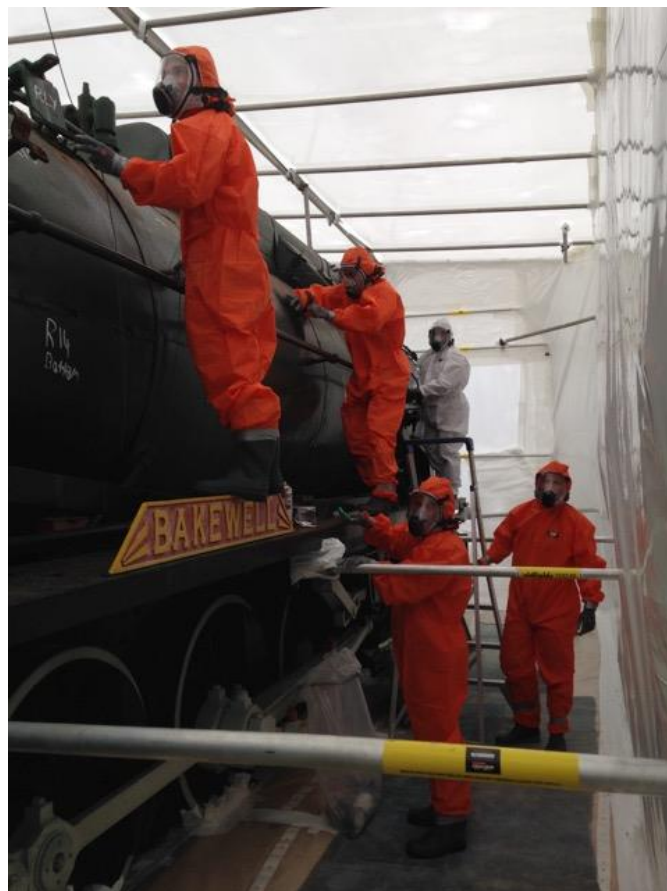
Western Australia's Public Transport Authority (PTA) knew that the locomotive contained friable asbestos blankets. However a closer inspection after the removal process commenced found asbestos was much more widespread, in insulation around the boiler and loose fill fibre clumps on the firebox and packed around the front smoke stack. This would not be a simple task. The size of the train, its heritage value, its highly public location and the friable nature of the asbestos all presented challenges.

The PTA engaged Thuroona Services, a 40% Indigenous-owned removal company, to do the job. Thuroona thought through every aspect of the process in minute detail to ensure the safety of its workers and the general public. Thuroona used state-of-the-art equipment and put back-up measures in place at every stage of the removal process to be absolutely sure that not a single fibre would be missed.

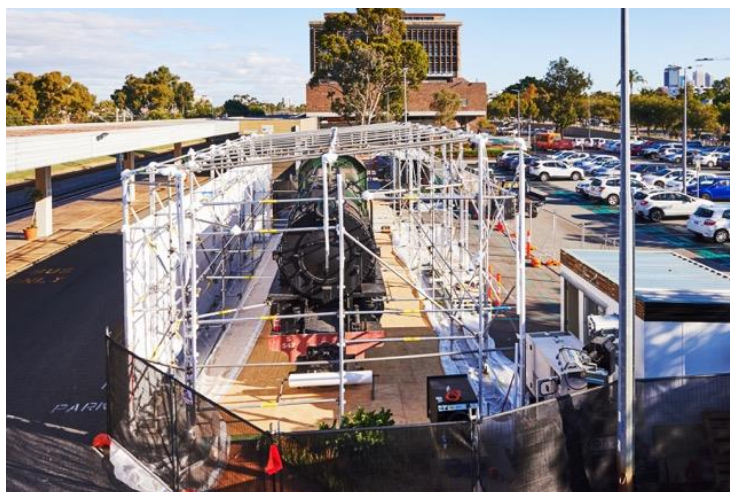
Thuroona erected a giant scaffold around the locomotive, as can be seen below. Knowing that heavy rain was predicted they decided on an extra safe construction method, using steel, instead of wood, bolting the scaffold to the ground and having the quality of the construction independently checked.

Thuroona then built a false floor around the train, hard up against the tracks, covered the floor in plastic and erected a double walled plastic enclosure (a bubble) around the whole train. The bubble was heat shrunk to make it airtight and smoke tested to ensure there were no leakages. They chose a thicker plastic than what is required by legislation because of the increased risks in a public location.

The enclosure was then put under negative pressure. This was to ensure it was completely sealed, so that all particles in the removal area could be sucked out through the filtration system. Thuroona used a manometer to consistently monitor the air pressure throughout the removal process, to ensure there were no leakages. A three door airlock prevented any air movement between the work area and outside.

The public location meant the site was at risk of being breached by vandals. The walls of the bubble were constructed one metre apart to ensure that any penetration of the first wall would be most unlikely to reach the second wall. Extra thick plastic, solid fencing and employing security guards outside of work hours also helped to mitigate any security breaches.

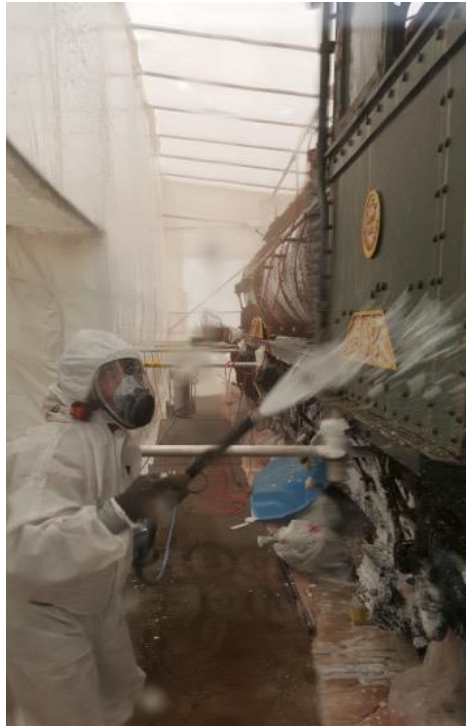
- ∂ Thuroona also owns a high-tech 5 stage mobile decontamination unit. The unit has two airlocks and is self-contained with its own generator and water. It has two showers, change rooms and spare respirators and other equipment. This unit was sealed to the bubble, ensuring that no workers could exit the contaminated area without going through the full decontamination process.

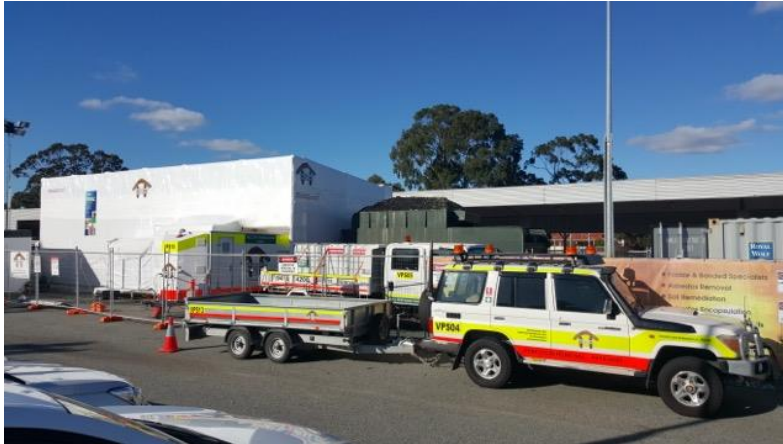
There is no requirement in WA to track asbestos waste during the transport and disposal process, but Thuroona felt that this was important to be able to demonstrate that safe disposal had occurred. Rather than outsource this process, Thuroona used its own vehicles which are 'mine-specced' (i.e. fitted with safety features such as signage and orange flashing lights). The vehicles also have GPS systems to track waste and cameras installed to provide video footage as an additional check in the event of an incident.
