Asbestos identified in Shantui Forklifts

Purpose

This safety alert provides information about the potential presence of asbestos in Shantui Forklifts imported from the People’s Republic of China (China).

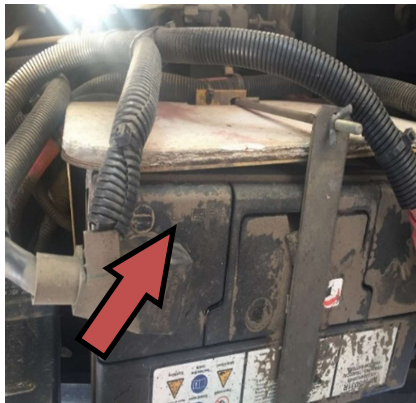
Figure 1: Asbestos insulating board above battery

It is recommended that users and owners of the forklifts inspect the battery compartment of the 3-tonne Shantui forklift for the presence of fibrous battery insulation material. If found, the forklifts should be isolated from use and a competent person (for example a Certified Occupational Hygienist, Licensed Asbestos Assessor or Licenced Asbestos Removalist) should be engaged to have a sample of the material analysed for the presence of asbestos.

If asbestos is confirmed within the battery heat insulation material, a competent person (for example a Licenced Asbestos Removalist) should be engaged to remove the asbestos material in accordance with the Safe Work Australia (SWA) How to manage and control asbestos in the

Consultation should be held with the forklift manufacturer regarding a replacement heat insulation material.

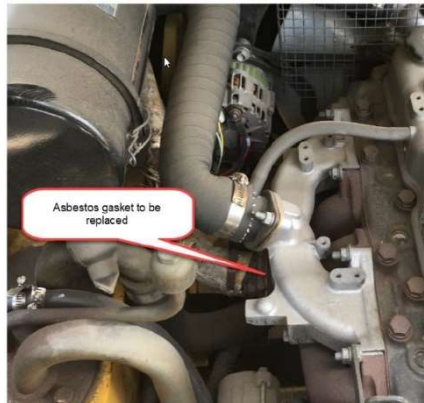
Figure 2: Exhaust manifold gaskets

The identified gaskets of the Shantui 3-tonne, 5-tonne and 7-tonne forklifts should be assumed to contain asbestos. Components identified with asbestos must only be removed by a person who is competent to do so safely. Appendix E of the SWA code of practice provides an example of a “working with asbestos friction materials” safe work method that can be used, including appropriate personal protective equipment, decontamination and disposal of the asbestos waste.

Spare gasket materials of the same brand should also be assumed to contain asbestos unless testing confirms no asbestos is present. Alternatively, the spare gaskets can be disposed of as regulated waste and replaced with gaskets that are certified as asbestos free in accordance with Australian requirements.

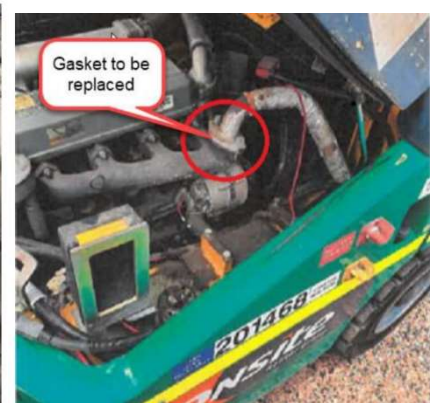
Figure 3: Exhaust manifold gaskets

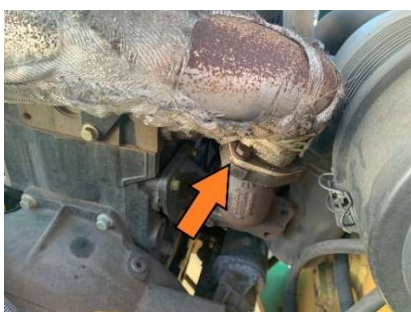
Figure 4: Exhaust flange gasket

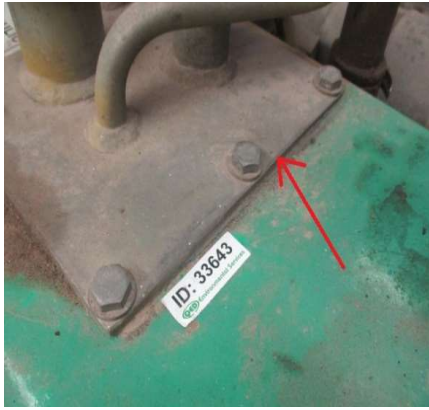
Figure 5: Hydraulic tank gasket

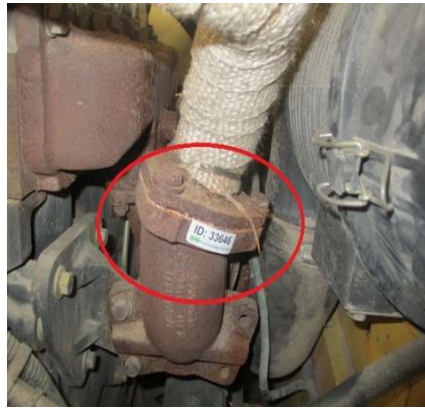
Figure 6: Exhaust flange gasket
