## INFORMATION SHEET

### Asbestos in natural stone products

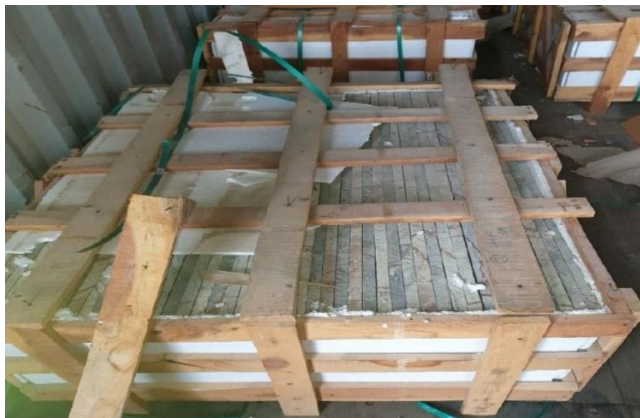
**Figure 3:** Imported cut stone tiles from India described as Bidasar Green and Bidasar Brown 'marble' found to contain asbestos.

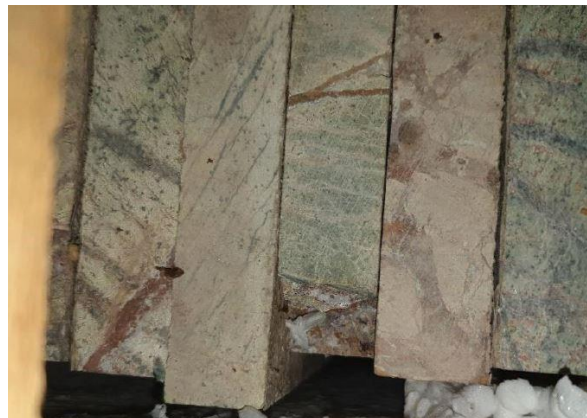
**Figure 4:** Close-up of area where sample was collected from one tile.

Identification of asbestos must be achieved by testing samples in a laboratory appropriately accredited for asbestos analysis. The sampling process should be undertaken by a professional with experience and qualifications who can determine the suspect area from which to sample. Inspection by an appropriately qualified and/or licensed professional might result in a determination that sampling and testing is not required – this position should be supported by a written statement setting out their conclusion and the reasons for this. The identification process needs to also consider the various types of asbestos that may be present, as this will determine the testing method needed to identify asbestos in the stone product.
