Case studies of contaminated land

Case studies of asbestos contaminated land

Final Report

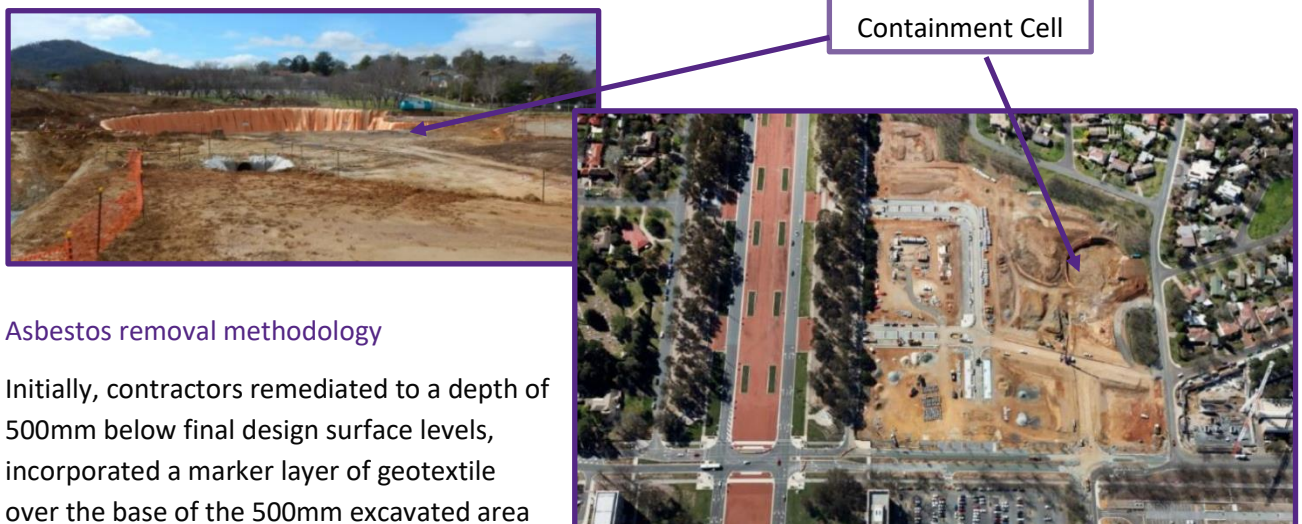
Figure 1.3: Construction of a 10,000 m³ containment cell for low risk BRU material (left image), and the site in August 2014 (right image), with remediation complete on all subdivision blocks while infrastructure works were progressing.

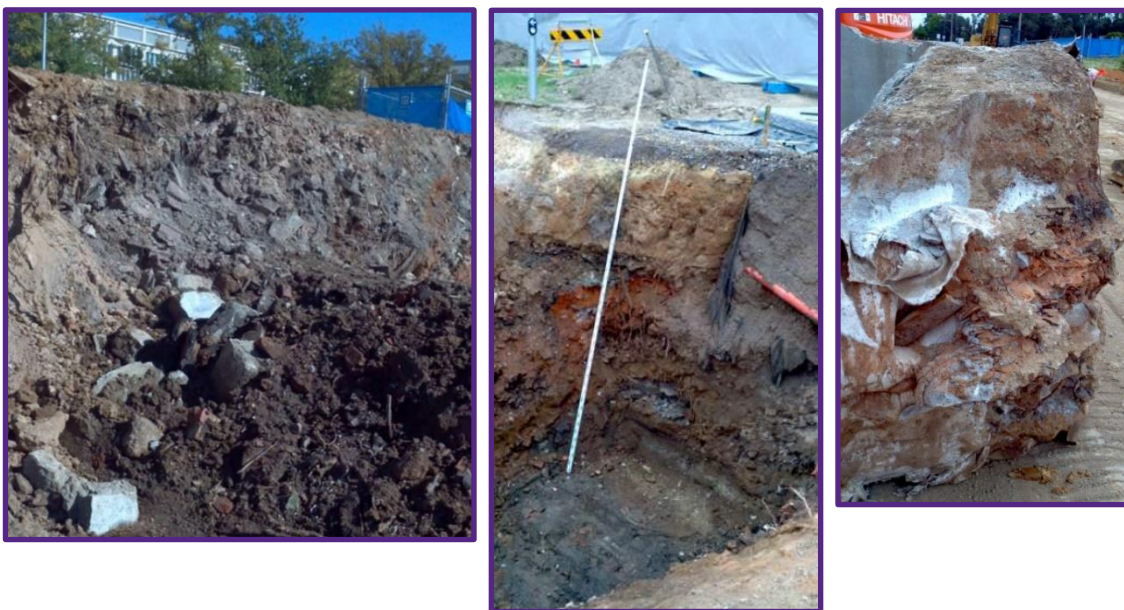
Figure 1.4: Asbestos contaminated soil along the southern boundary of the site (left image), an excavated section with up to 4 metres of highly contaminated soil underground (middle image, note the staff is 5 metres long), and asbestos containing material stuck to the outside of a concrete structure that was removed from the ground (right image)

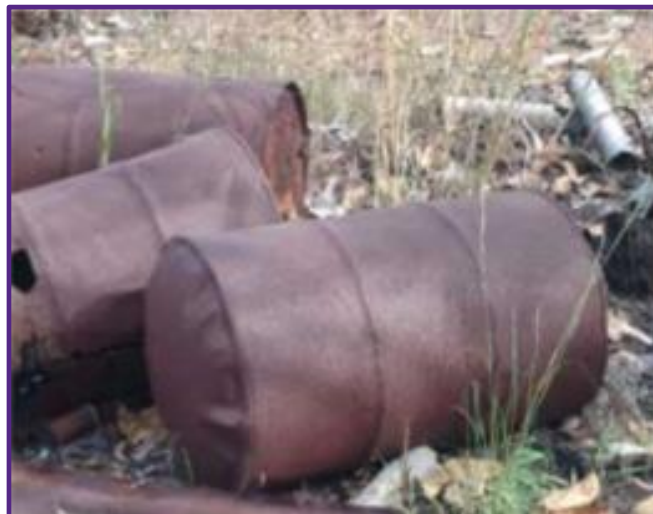
Figure 2.3 – Discarded drums and pipes

The sampling identified waste materials including metals, asbestos containing materials (ACM) and oil drums (see Figure 2.3) on the ground surface. Below the ground surface, investigations also found ACM contamination in tip sites, general rubbish areas and in underground services.

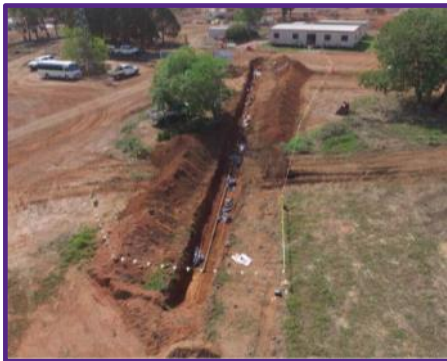
Figure 2.4 – Removal of buried asbestos conduit

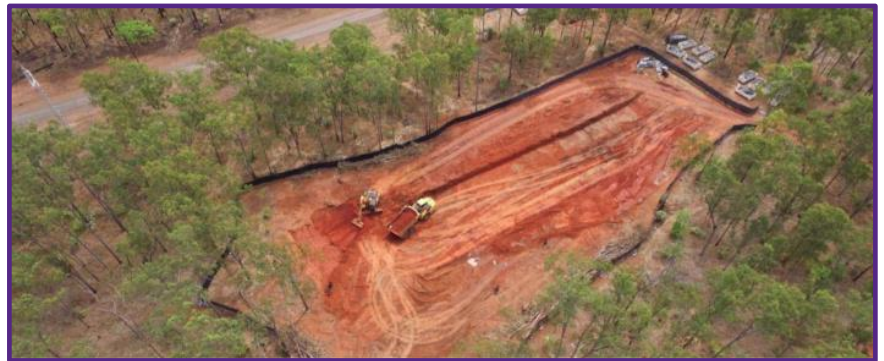
Figure 2.5 – Rehabilitation of a tip site

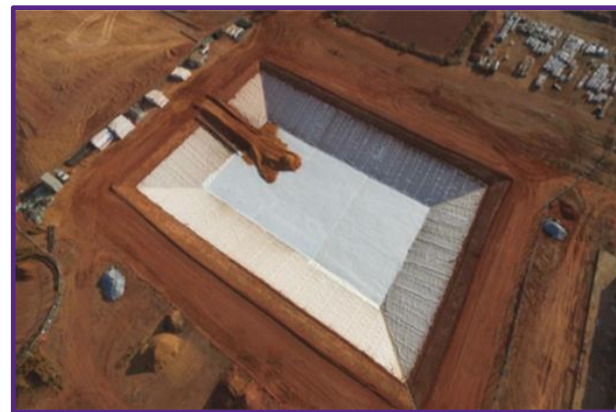
Figure 2.8 – Containment cell

To manage the risks associated with the containment cell, ongoing monitoring was undertaken during its construction. The monitoring included noise, odour, emission levels (air quality), soil and groundwater. The results were continually reviewed by project staff to ensure that compliance with regulatory requirements was maintained.

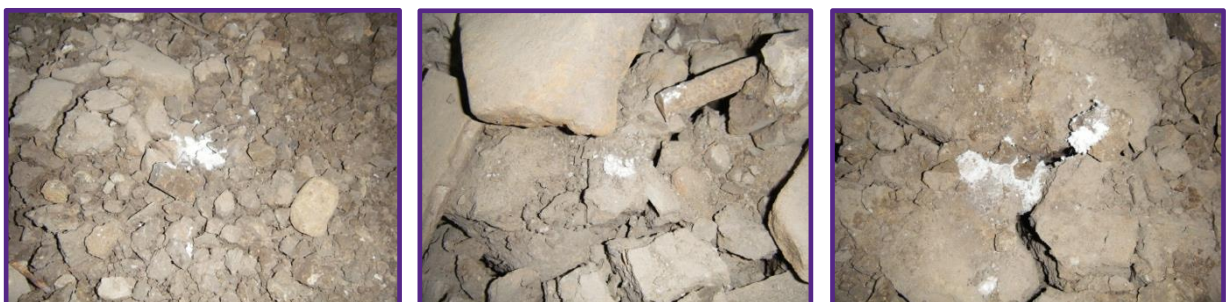
Figure 3.2 – Asbestos debris found in the soil

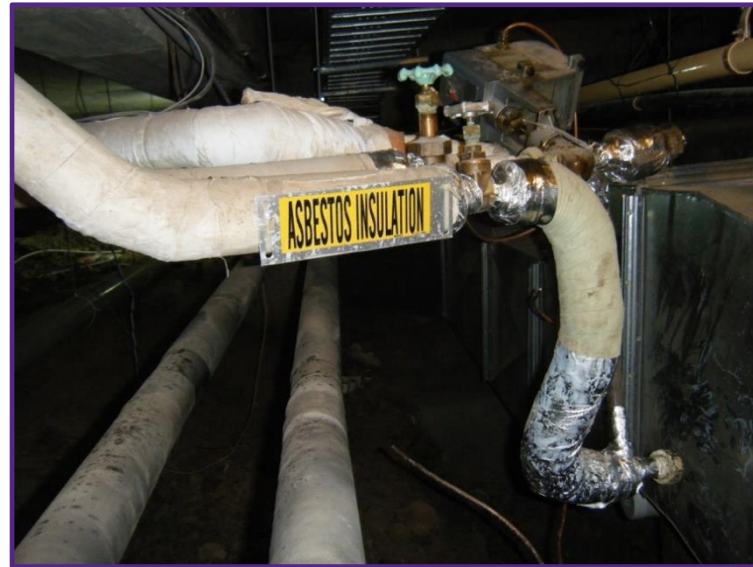
Figure 3.3 – Part of the remaining asbestos-lagged pipework

The initial response by Launceston Airport was to isolate the undercroft area with no access allowed and appoint a licensed asbestos assessor to investigate the extent of the contamination. The assessor found that there was a mix of both older asbestos and newer non-asbestos lagged pipework in the undercroft, with asbestos debris visible under and around the older pipework areas. The assessor took soil samples under both the old and newer pipework areas for testing at a NATA certified laboratory. Results showed that asbestos contamination was present in both areas, indicating some ineffective historical removal of old asbestos-lagged pipework and replacement with newer pipework.

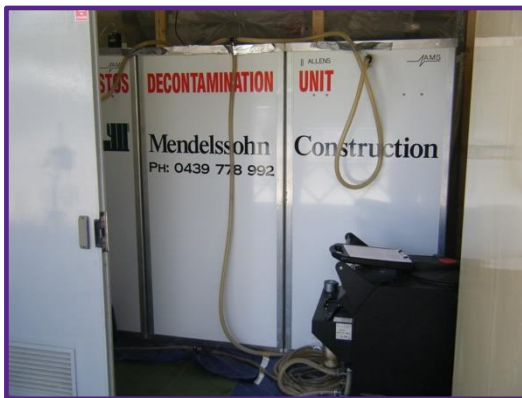
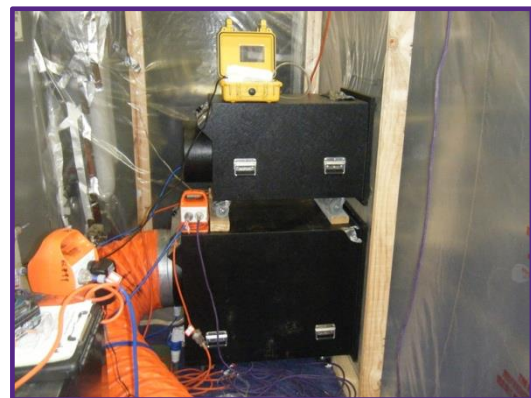
Figure 3.5 – Decontamination unit and enclosure used for the project

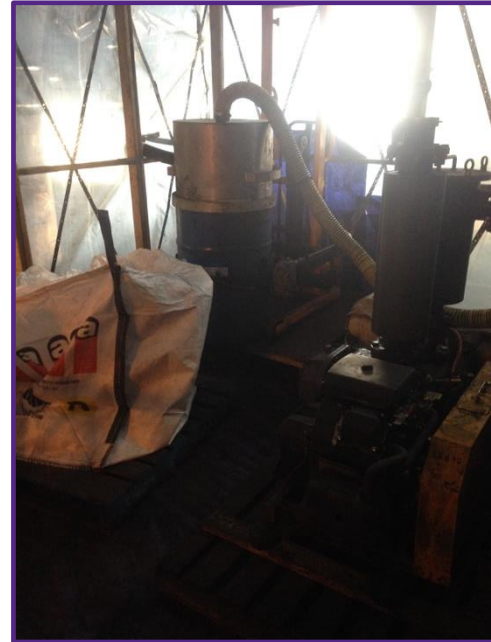
Figure 3.7 – Vacuum unit located inside the enclosure

Soils that were removed by vacuum were collected in drums and bags inside the enclosure. Once full, the drums and bags were decontaminated using a wet wash and glue spray. These were then stockpiled until they could be removed after hours using an EPA licenced vehicle.

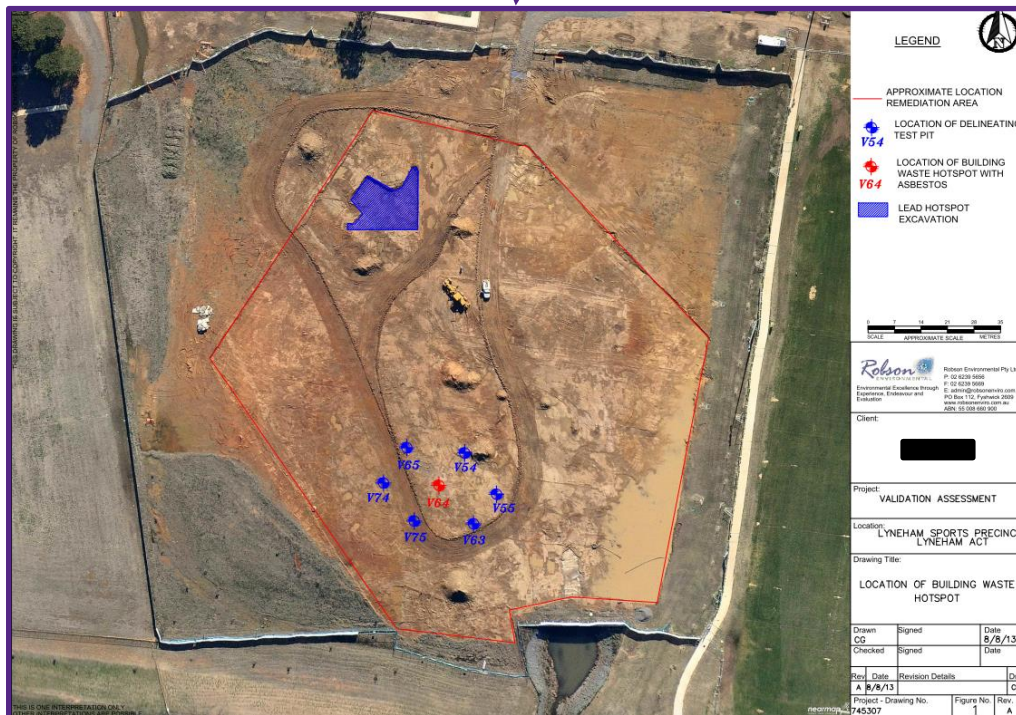
Figure 4:2: Sites that were being upgraded (top image, Zones A - E), and location of ACM soil (remediation area, red line) and asbestos waste 'hotspot' (bottom image, red dot)

Asbestos Type	Quantity	Locations
Amosite (Brown), Chrysotile (White) and Crocidolite (Blue) in pipes and cement sheets.	Approx. 13,200 tonnes	Zones B and C (see Figure 4.2). Found in building rubble buried in the soil.

As ACM was identified in the top 250 mm of soil, it was recommended that the top layer to this depth be removed from a significant area within Zone B and C, as well as removal of the asbestos in the 'hotspot' (see image 2 from Figure 4.2). Approximately 13,000 tonnes of asbestos contaminated soil was excavated and safely removed from the site while other sporting areas continued to hold sporting activities. The asbestos contaminated soil was transported to the local licenced landfill, 16 kilometres away.

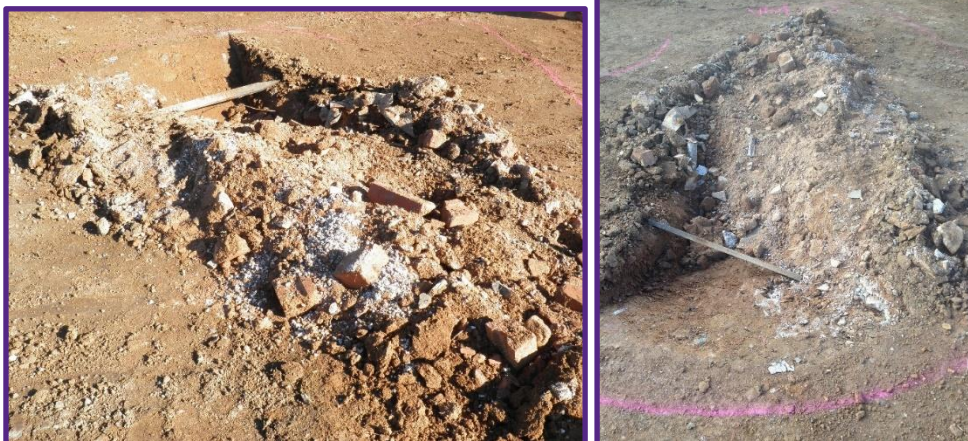
Figure 4.3: Asbestos contaminated soil found at the site

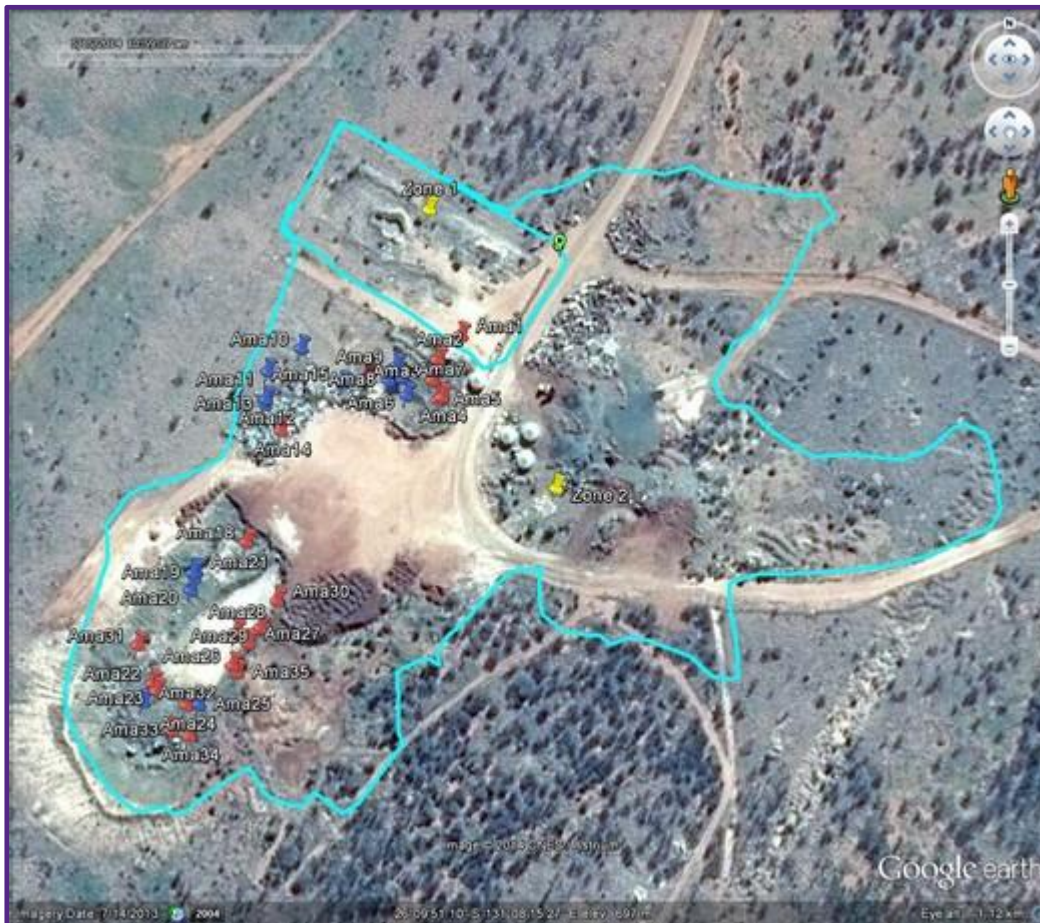
Figure 5.2 – GPS mapping of sampling of landfill area

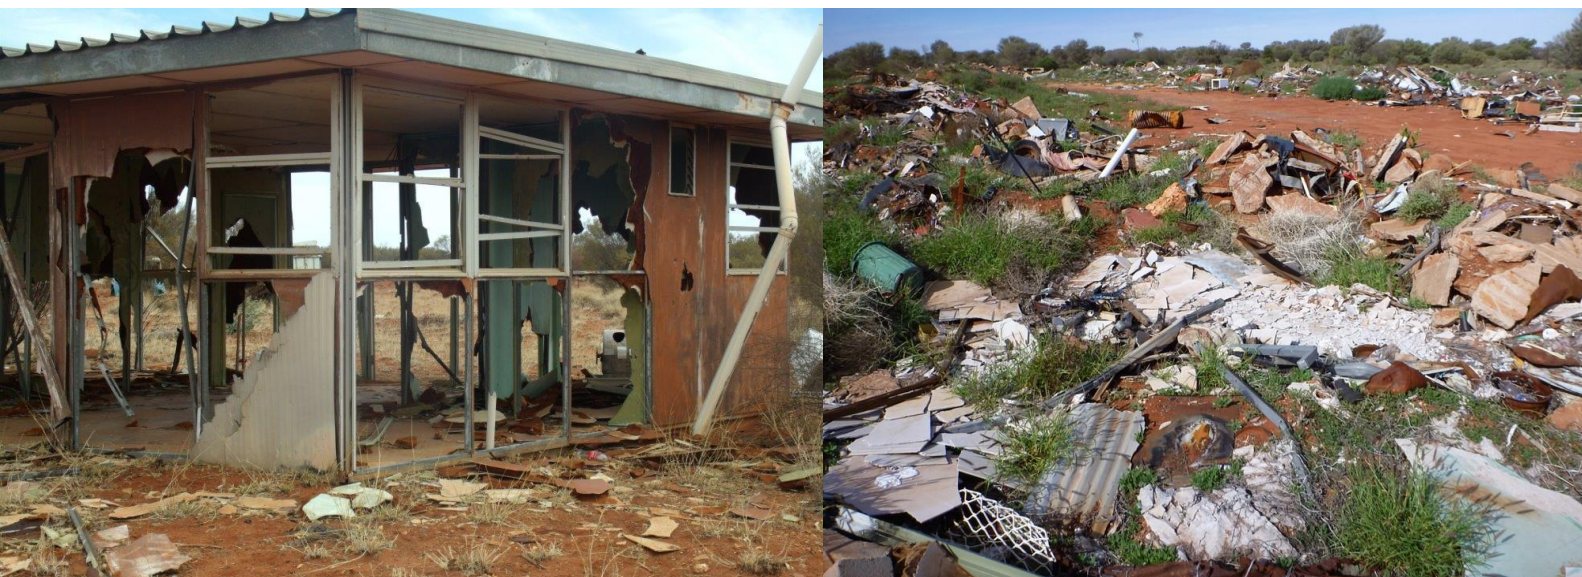
Figure 5.3 – Typical condition of the landfill sites at the start of the program

The ACM was scattered around the landfills, often amongst piles of building rubble, soil and hard waste. Samples had only been taken from above ground and as such the amount of hidden ACM was unknown. Much of the ACM is considered to have originated from government funded housing and building construction dating back several decades.

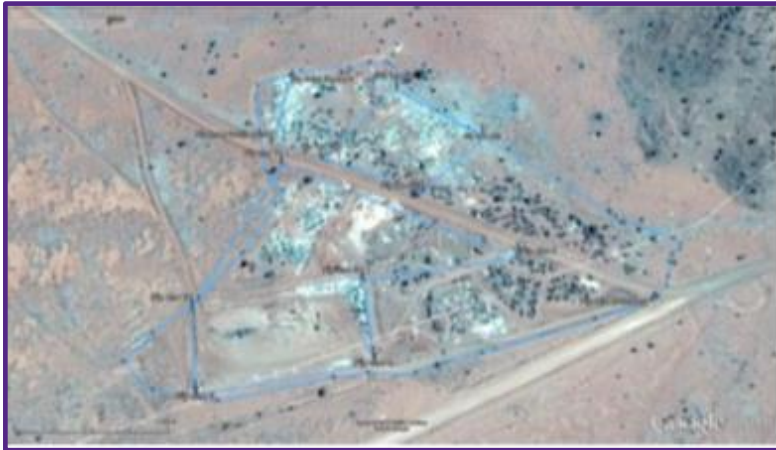
Figure 5.5 – Pilpalyatjara landfill site with clean-up boundaries indicated

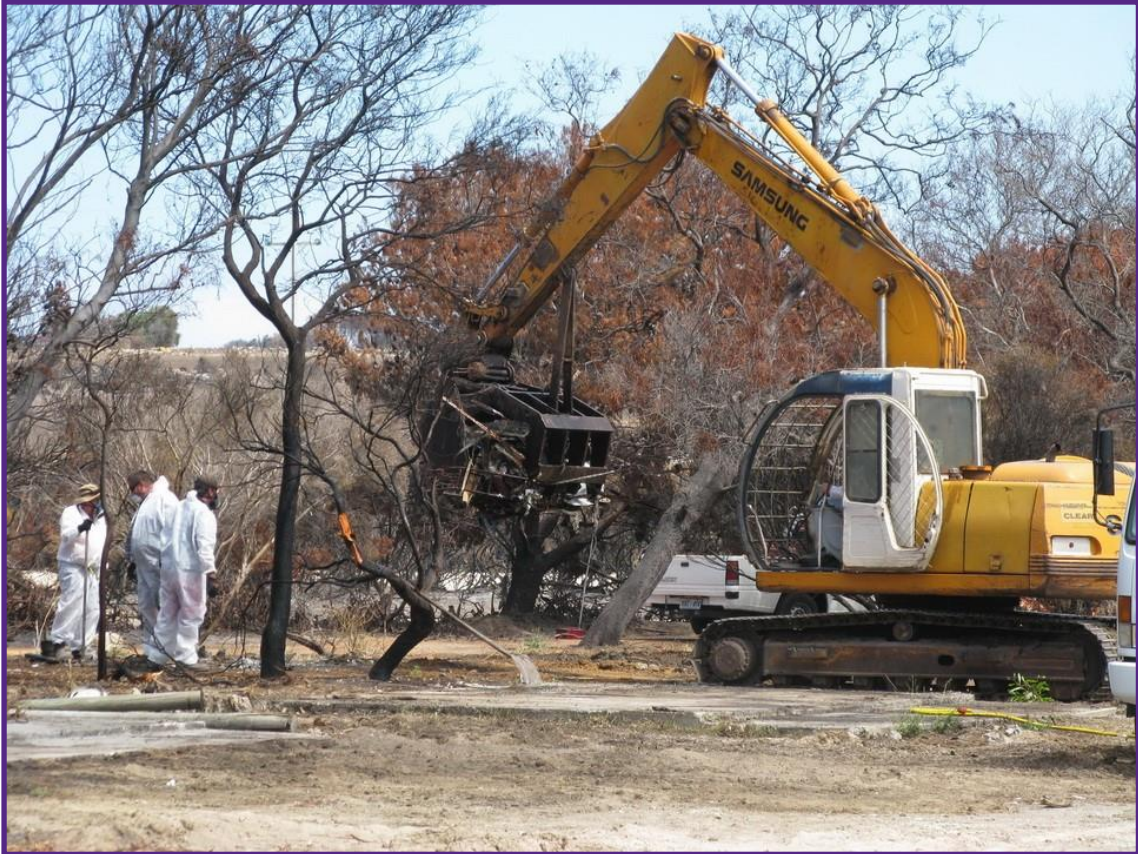
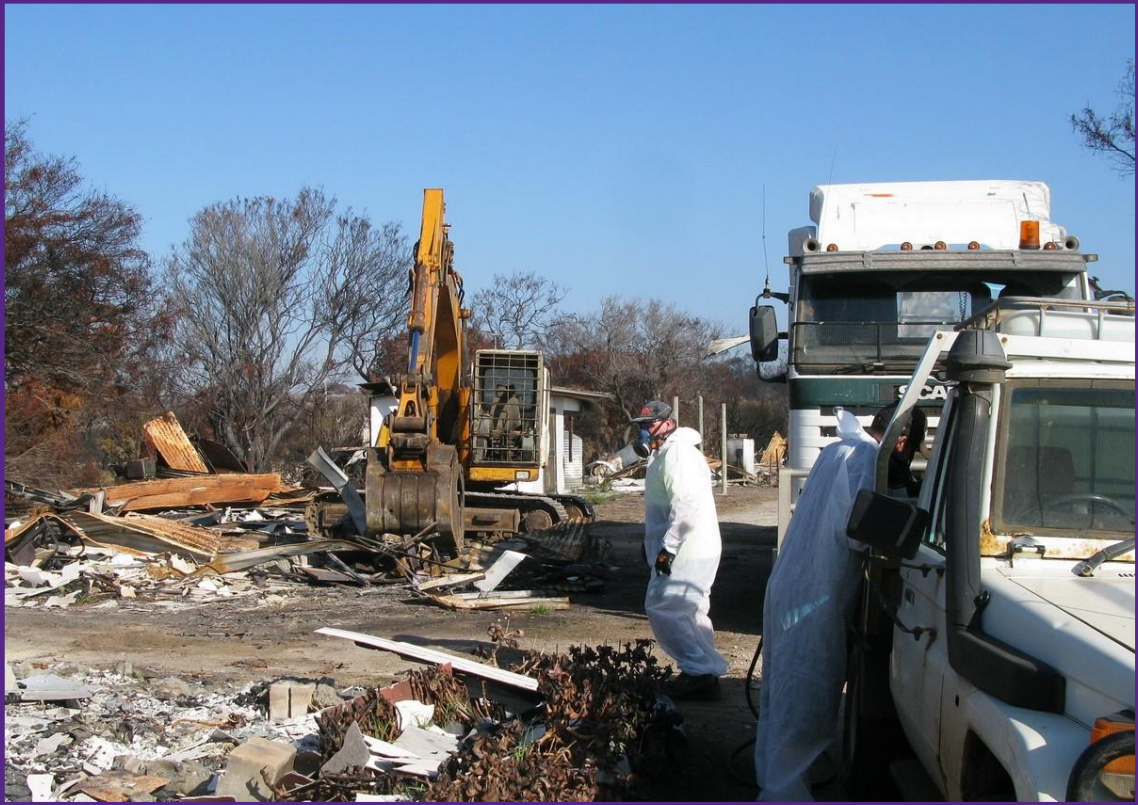
Figure 6.2: Removal of asbestos containing materials

- Removal and disposal of all asbestos cement material situated on site including above ground (see Figure 6.2) and in the top layer of the soil;
- Air monitoring on site whilst removal work was in progress;
- Removal of fire damaged sheds, containing asbestos cement material;
- Transportation of all asbestos material to be carried off site by an EPA approved contractor with licenced vehicles (this was transported to the Port Lincoln landfill);
- Site tidy up upon completion.

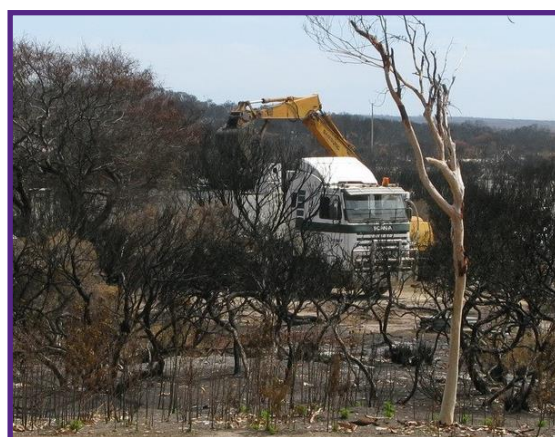
Figure 6.3: Asbestos contaminated materials being loaded into a truck

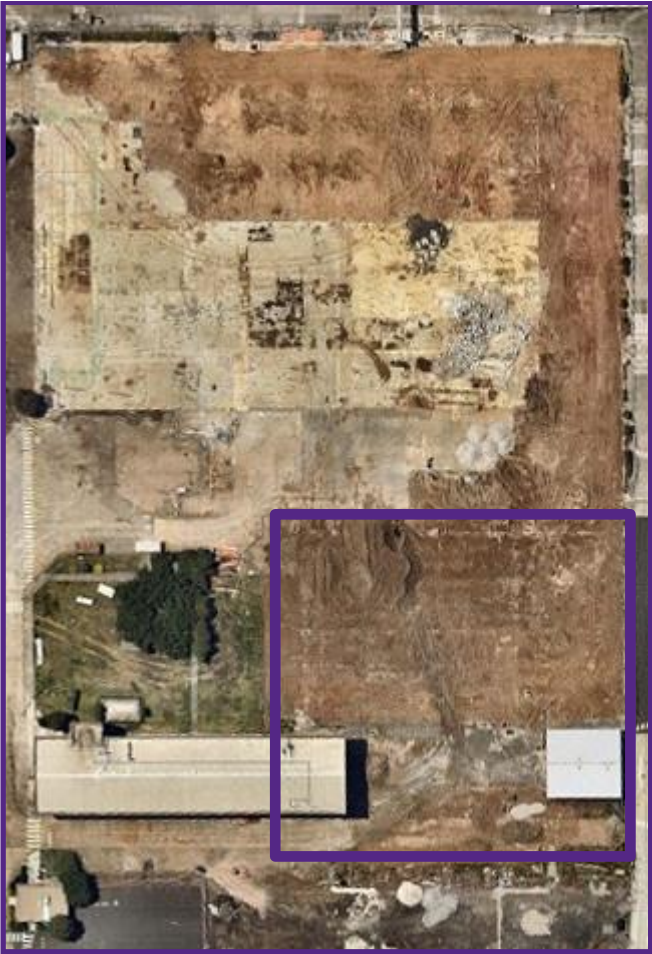
Figure 7.2: A section of the company’s site, with ACM contaminated soil fill area located within the purple square

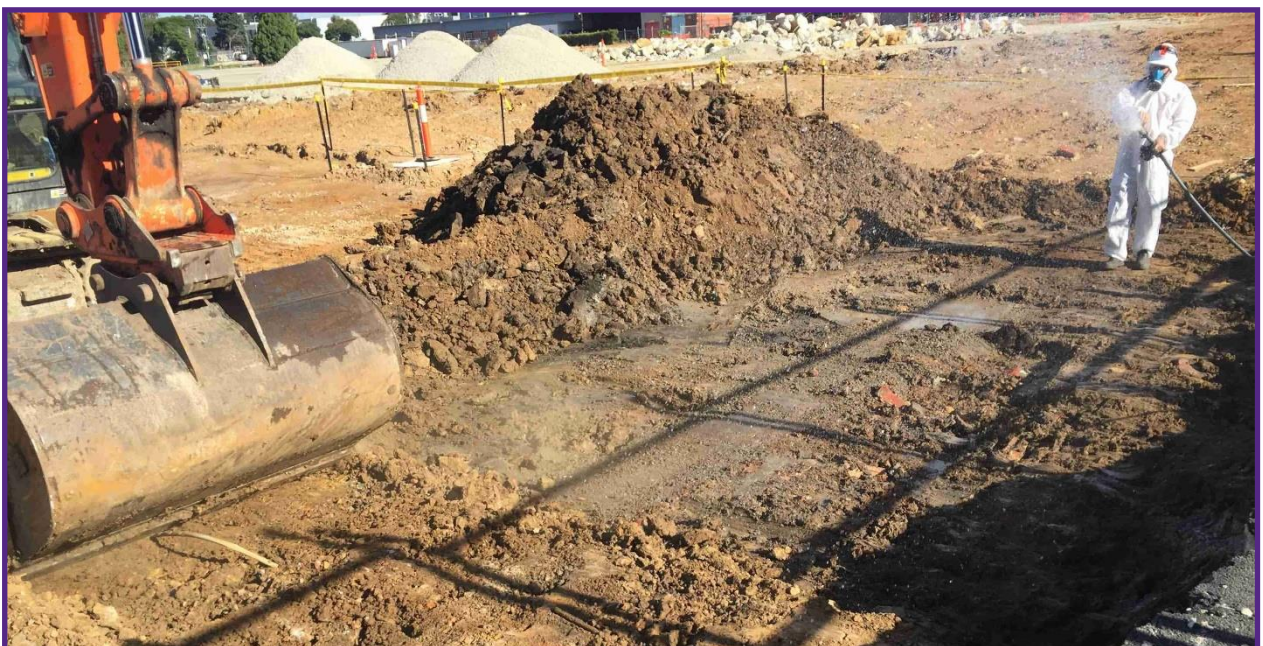
Figure 7.3: Asbestos removalist keeping the asbestos contaminated soil moist

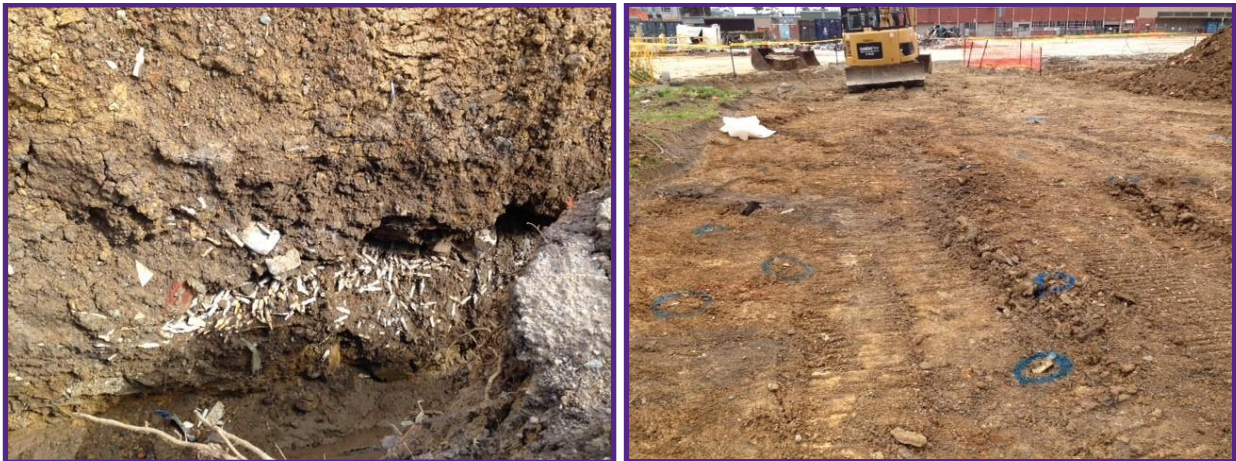
Figure 7.4: Asbestos contaminated soil found during the project (right image has asbestos circled in blue)

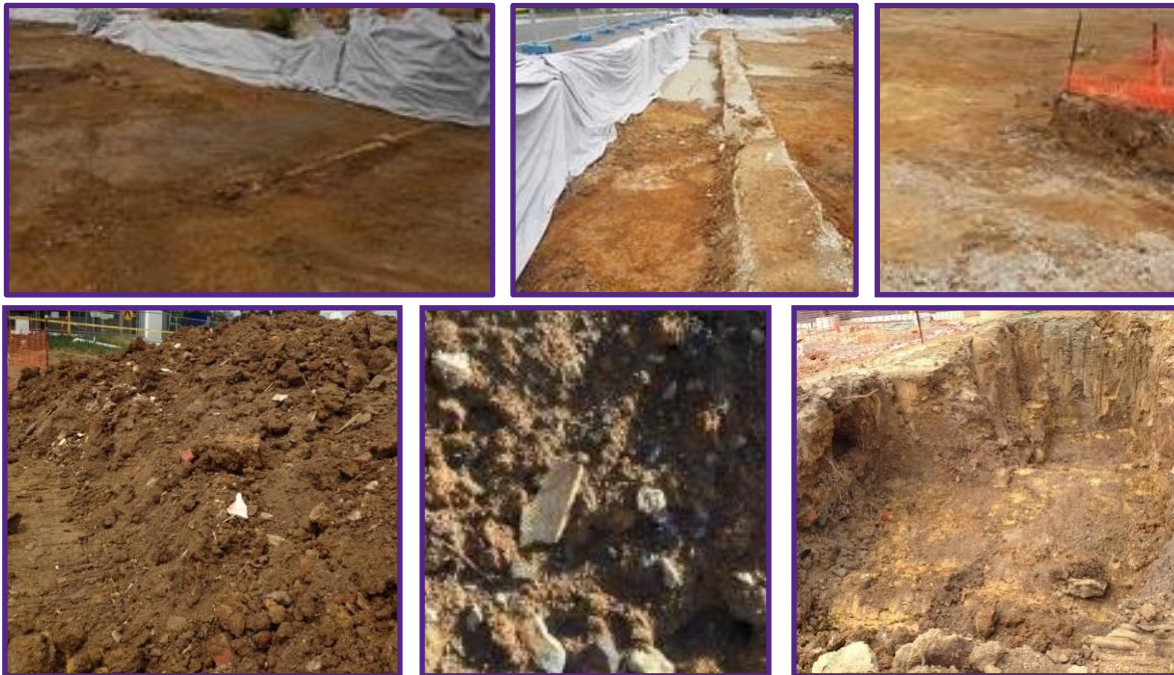
Figure 7.5: Pictures of the remediation program (top) and evidence of asbestos in soils (lower)
