ASEA REPORTS

Case studies of
asbestos water pipe
management practices

Case Study 1 – Goulburn Valley Water, Cameron Avenue

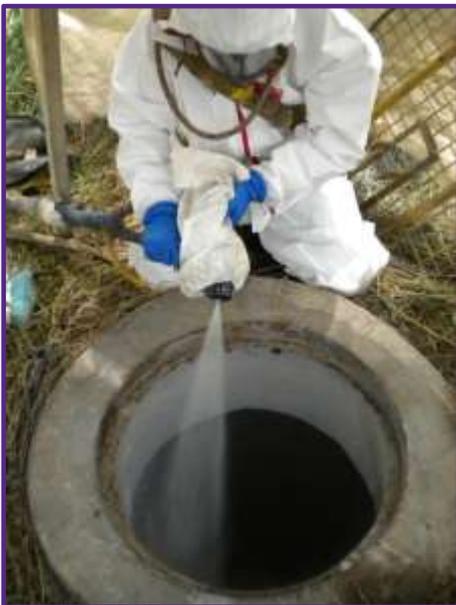
Figure 2.3: Manholes showing signs of deterioration being repaired. A special coating is applied to restore them to original condition.

The remediation work is then undertaken across two phases. Firstly, manholes showing signs of deterioration are sprayed with a special coating that looks to restore them to their prior level of performance. This technique can be done directly into the manhole without the need for excavation and removal. Figure 2.3 shows a manhole being repaired using the relining technology.

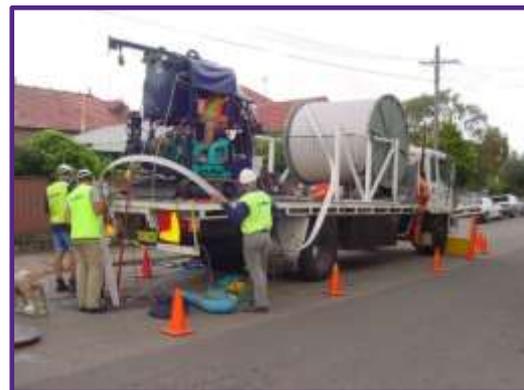
Figure 2.3: Pipes being repaired via trenchless technology

Secondly, pipe areas targeted through the camera investigation are repaired using innovative trenchless relining techniques to correct faults, rather than being replaced. This is a ‘no-dig’ and cost-effective way of renewing the pipe. In most cases, the new pipes are formed on site by taking a continuous strip of profile and spirally winding it inside the damaged pipe, forming a new, water-tight structural pipe within the host pipe (see Figure 2.4).

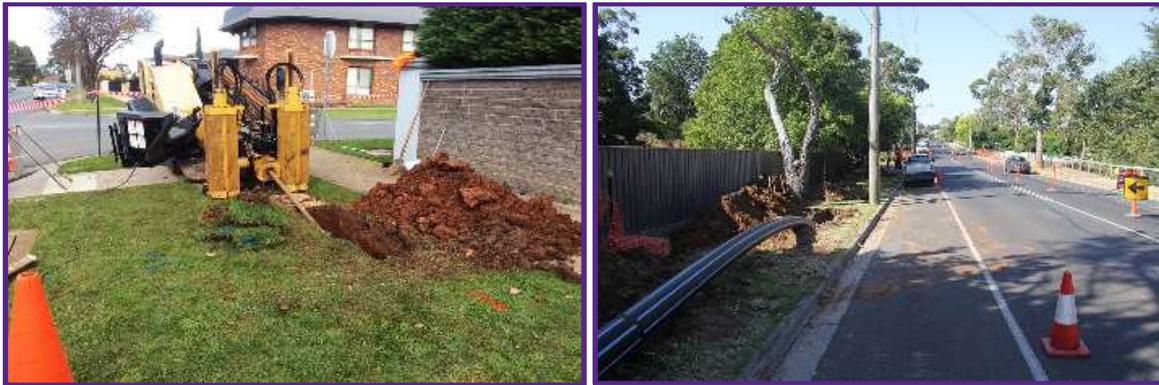
Figure 3.3: SE Water using the realign and leave technique for pipe renewal

In response to the release of WorkSafe Victoria's guidelines in March 2015, SE Water now favours the 'realign and leave' technique (often referred to as "by-passing")¹⁵. This was decided after consideration of the risks and benefits associated with each technique, OHS requirements and approval by the SE Water Board. There is an expectation that SE Water will continue extensive customer engagement as well as exploring emerging alternatives (see next section). Figure 3.3 shows SE Water conducting pipe renewal using the realign and leave technique.

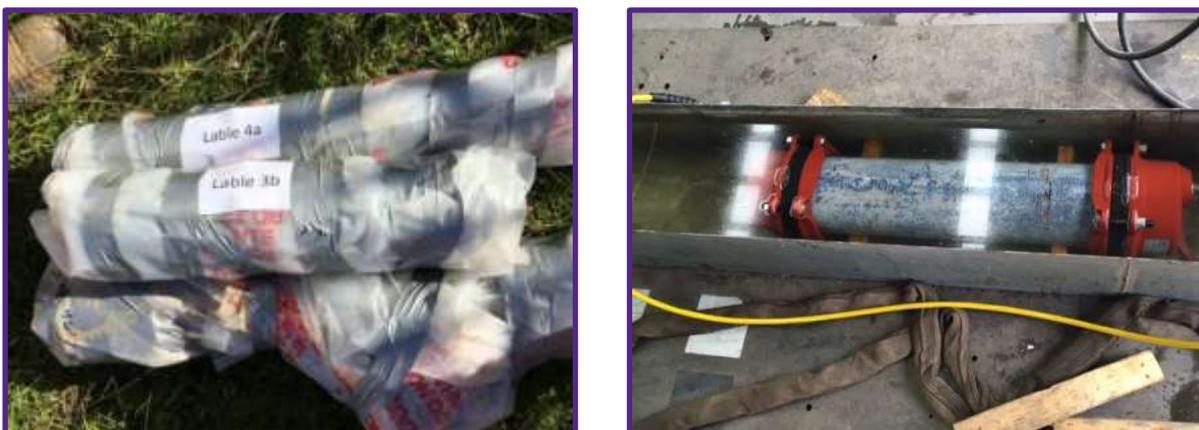
Figure 3.4: Example AC pipe renewal techniques that have been considered (left image is exhumed cured in place samples that were extracted to be laboratory tested, right is cured in place break test apparatus being tested)

SE Water's strategic approach to AC water pipe renewal includes consideration of new and emerging techniques that may be safer and more cost effective. These are outlined below (and presented in Figure 3.4):

- Non-Structural liners, where an organic polymer is sprayed on the internal pipe wall. This can span gaps and prevent leakage.
- Semi-Structural Spray on linings, which is a thicker layer of organic polymer that provides some structural properties.
- Cured in place semi-structural liners, where an inflated hose is placed in the pipe and cured or sealed in place using steam/hot air.
- Cured in place structural liners, which is the same as the cured in place semi-structural liners but the lining is reinforced with fibreglass to provide structural strength (the liner does not rely on the host pipe)¹⁶.

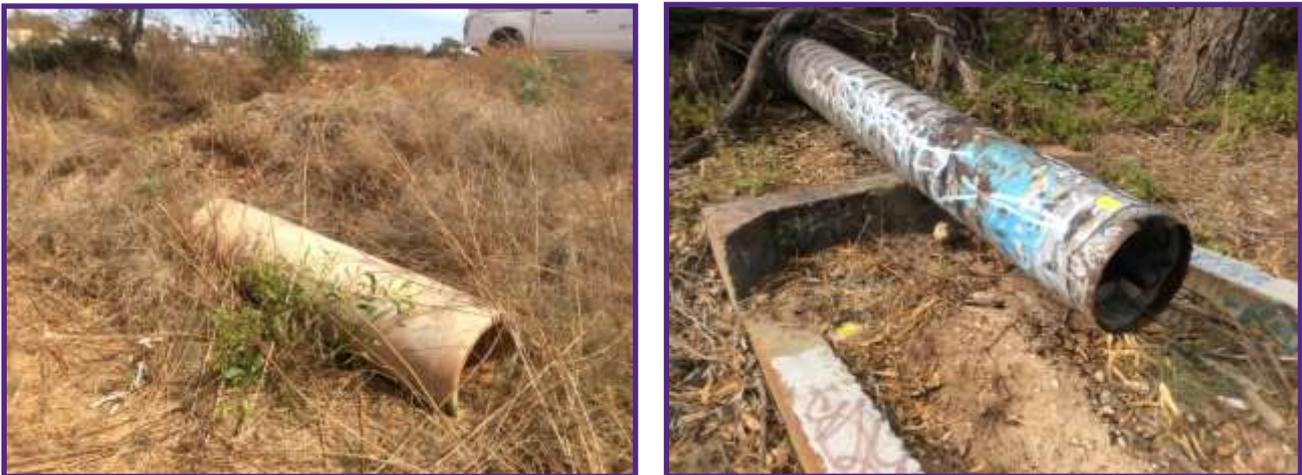
Figure 4.1: Common asbestos pipes found at Water Corporation (left image - AC Pipe Exterior of Compound in Karratha, right image – asbestos bitumen coated pipe in Karrinyup

Water Corporation's *Working with Asbestos* policy outlines the management and removal process for all ACM on or in the company's assets. This includes AC pipes and bitumen coated steel pipes (see Figure 4.1). This document indicates that these pipes "should be removed from the ground when decommissioned unless operational or safety constraints would it [sic] unfeasible". If asbestos pipes are left in the ground, this is tracked through data management programs such as LiteSpatial and MyWorld.

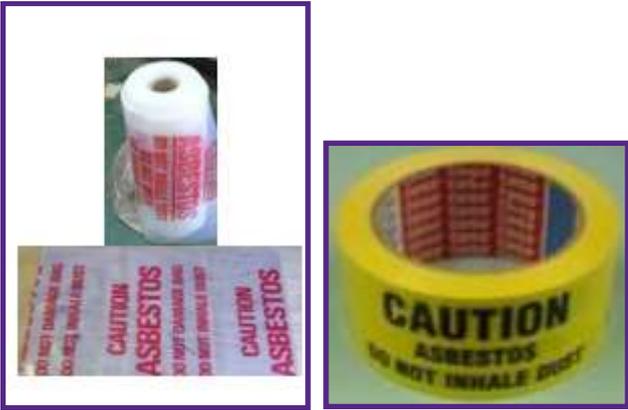
Figure 4.2: Equipment used by Water Corporation for asbestos removal (left image – disposal sheets (200 nm) or bags, right image – duct tape used to seal bags/wrapping)

- vi. The ACM is double-wrapped in plastic sheeting, fully sealed with duct tape and labelled. Water Corporation has asbestos disposal bags for the asbestos pipe (see Figure 4.2);

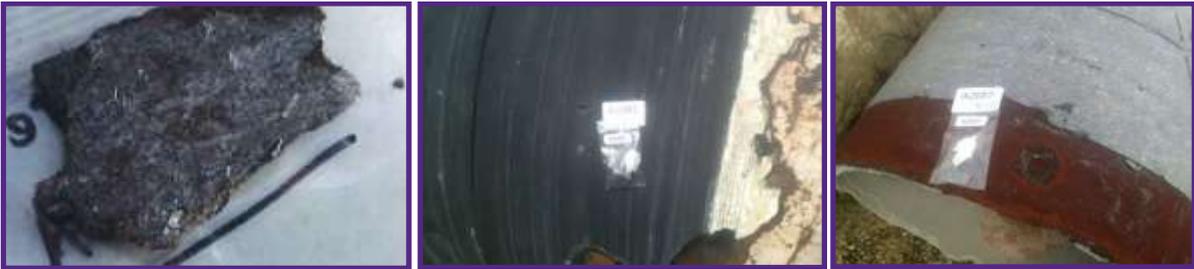
Figure 4.3: Coal tar or bituminous wrapped pipe pieces (on Water Corporation’s assets, these may contain asbestos and as such is treated as though it contains asbestos)

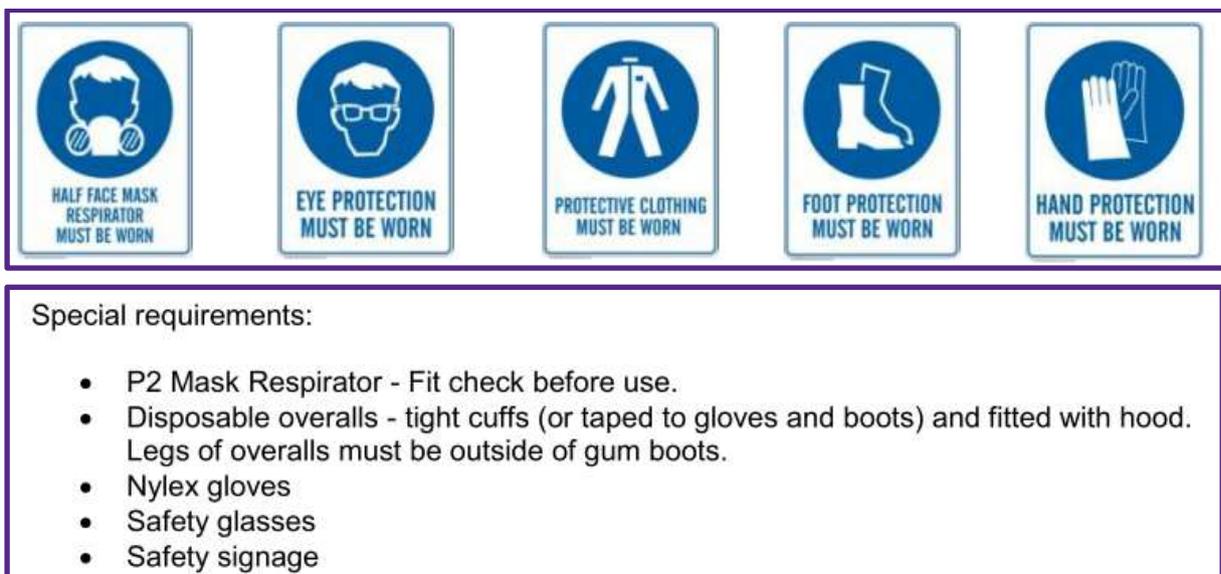
Figure 5.2: PPE that employees and contractors must wear when cutting or in the vicinity of cutting asbestos pipes (including the special requirements)

- **Personal Protective Equipment (PPE)**
 - The operator and anyone assisting with the cutting or in the vicinity of the cutting operation must (see Figure 5.2 for further details):

- Wear appropriate respiratory protective equipment, protective clothing and/or safety equipment.
 - Wear approved waterproof trousers, waterproof jackets, shower cap, or disposable overalls, rubber boots and rubber gloves taped to the outside of the jacket / overalls.

- Wear a respirator fitted with an approved respiratory P2 Filter.

1. Wear appropriate PPE (see Figure 5.2);
2. Excavate to the depth of pipe, expose length of pipe using hand dig methods;
3. Barricade area;
4. Where pipes must be cut, the removalists use a hand saw or chain cutters. If unable to cut, removalists place a wet rag around the collar, wet the area down and hit the collar with a mash hammer and chisel away the collar. Power tools are never used;

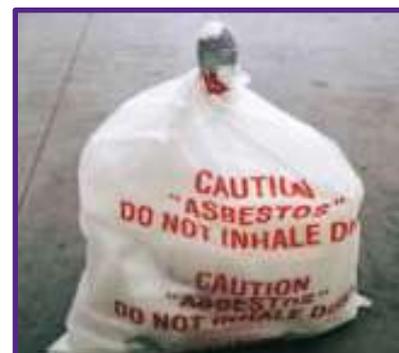
Figure 5.3: AC disposal bag, goose necked and sealed

6. Replace the pipe;
7. Wash down tools, equipment and PPE (if for re-use);
8. When complete, place PPE in AC disposal bag (see Figure 5.3 below), which is taken to a licenced landfill.

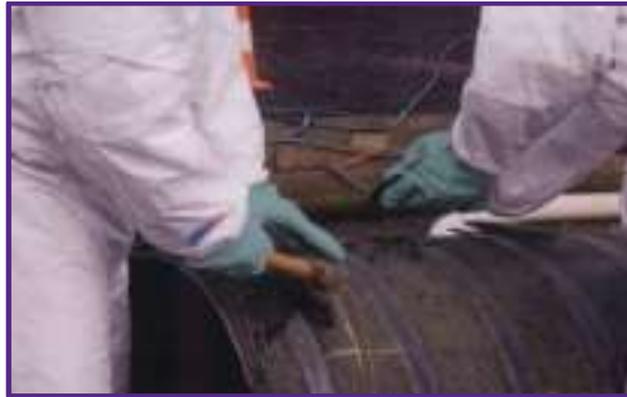
Figure 5.4: The hammer and chisel method used to remove asbestos from MSCL pipes

1. The pipe is taken out of the ground and removalists coat the area on the pipe to be removed with a mix of water/PVA or water based paint;
2. They then barricade the area and place a 200 micron sheet or bag under section of the pipe to be removed to capture waste as it is chipped away from the pipe;
3. The asbestos is then removed by chipping it away using a hammer and chisel (see Figure 5.4). If the wrapping is not totally removed from the pipe, the area is rasped to ensure all wrapping material is removed;

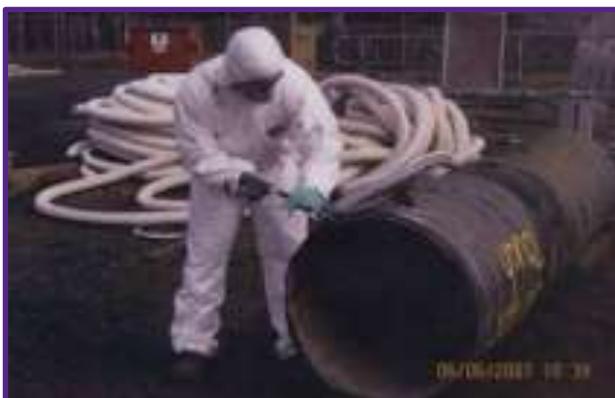
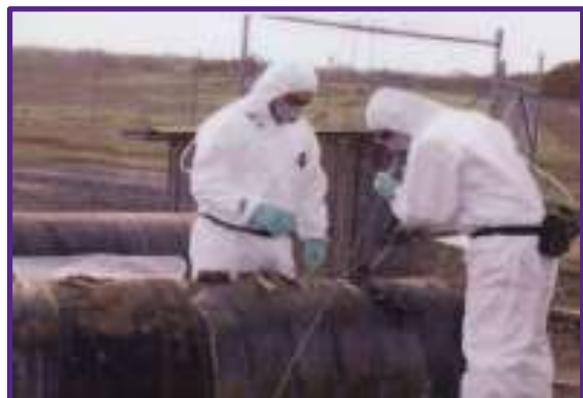
Figure 5.5: Asbestos pipe removalists undertaking removal works

4. The Class A removalist must ensure air monitoring occurs and the results are available to employees at the workplace. On the completion of any cutting operation, all equipment, overalls and boots must be thoroughly washed down;
5. Clean up and disposal
 - a. All major sections of pipe and asbestos wrapping, any disposable protective apparel and respirators / filters are placed in heavy duty (200 micron) polyethylene plastic wrapping, with small amounts of broken pipe and asbestos wrapping cleared from the trench and added to the bags,
 - b. These are disposed at a licensed landfill.

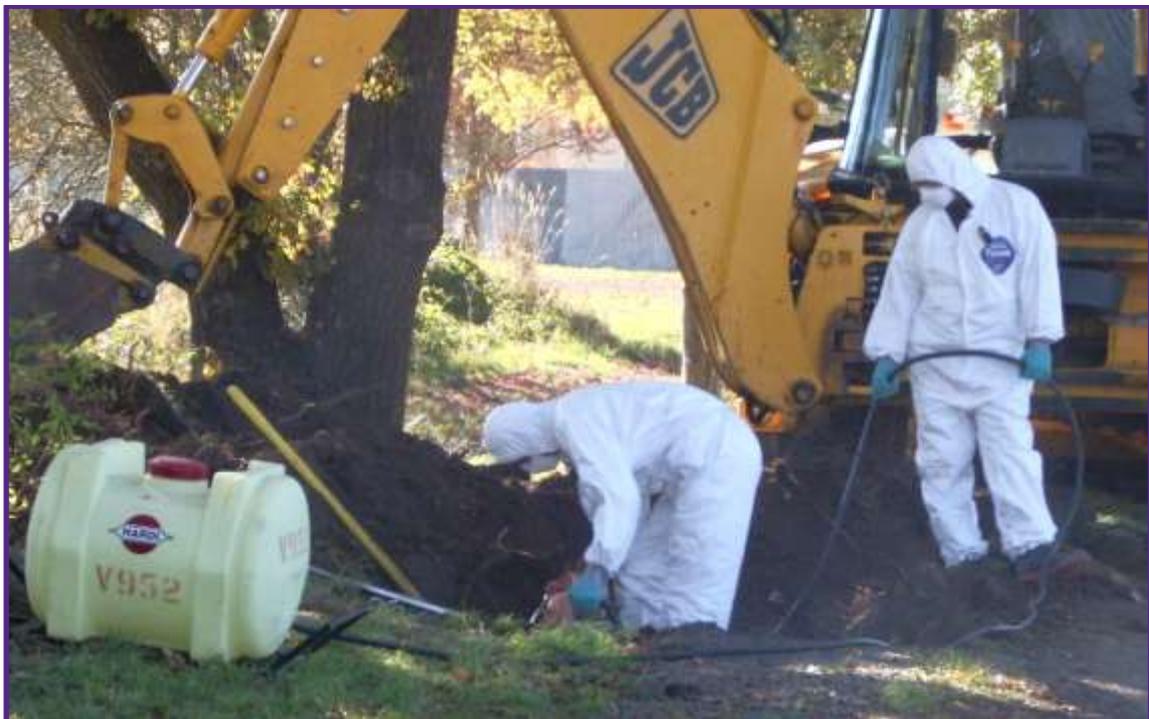
Figure 6.3: AC water main pipe removal using a demolition saw and with water continuously running

Central Highlands Water staff removed 6 metres of AC pipe on East Street in Daylesford (see Figure 6.2). Class B trained removalists from Central Highland Water used a demolition saw with water tank and pump to cut the pipe, with water continuously running on the blade (see Figure 6.3). This task took approximately three hours and required two staff members. Labour and equipment costs to repair the AC water main were estimated to be \$500 (this does not include training costs for staff).

8. Use manually operated compression chain cutters or handsaws to cut pipes if possible (although note that a demolition saw²⁶ stored in Central Highland Water's asbestos removal trailer (see Figure 6.3) is permitted if water is continuously running on the blade and is pumped using the electronic pump located on the asbestos removal trailer);
