**Australian Government**  
**Asbestos Safety and Eradication Agency**

# **Asbestos-Cement Water and Sewer Pipe Management Case Studies**

**September 2022**

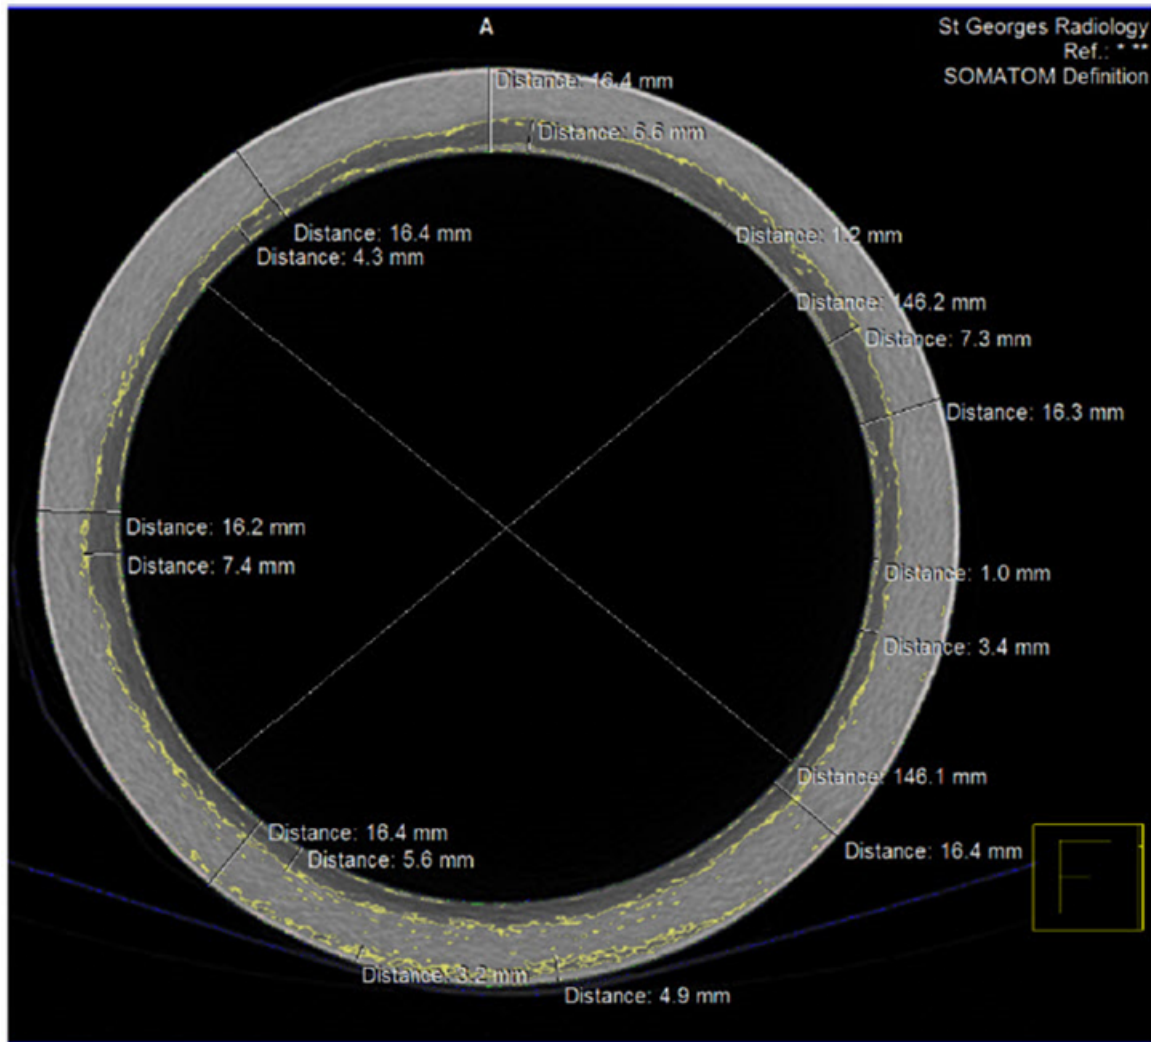
Figure 2.3 - CT image of a DN150 sewer rising main

Figures 2.3 and 2.4 show CT scan images of AC pipe samples.

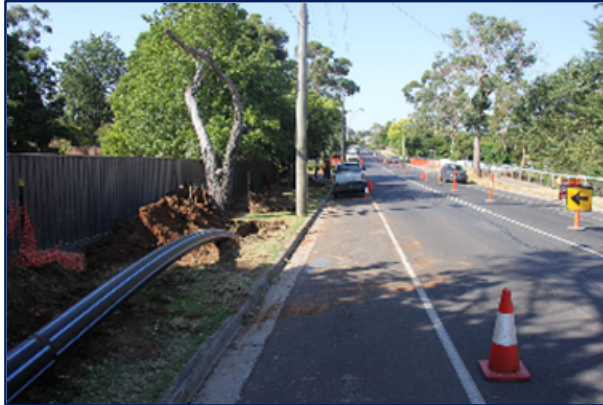
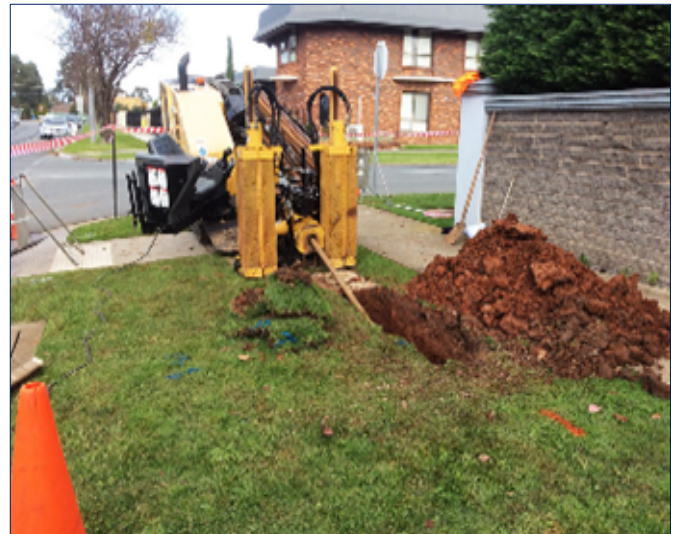
Photos: South East Water using the realign and leave method for pipe renewal.

- **slip-lining:** inserting a smaller pipe into the deteriorating AC main,
- **realign and leave:** construction of a new alignment and leaving the disused AC main in situ,
- **remove and replace:** the AC main is removed, and a new pipe is laid in the same trench,
- **pipe cracking/bursting:** a cracking head which is pulled through the host AC water main with a new high-density polyethylene (HDPE) pipe attached. This method has the advantage of not undertaking any surface reinstatement, reducing inconvenience to the community. Prior to 2015, SE Water had renewed approximately 150 kilometres of AC pipe using this method.

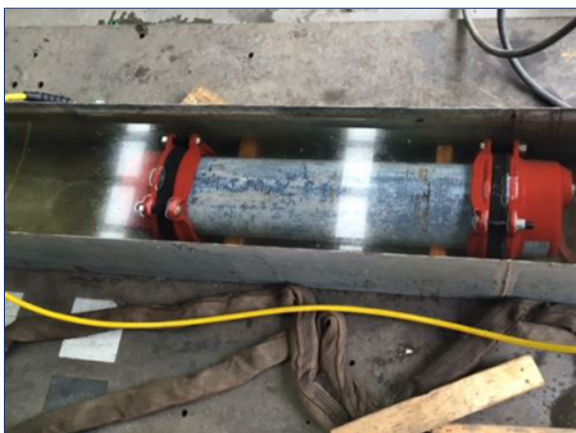
Photo (left): Exhumed cured in place samples that were extracted to be laboratory tested.

- Non-structural liners, where an organic polymer is sprayed on the internal pipe wall. This can span gaps and prevent leakage.
- Semi-Structural Spray on linings, which is a thicker layer of organic polymer that provides some structural properties.
- Cured in place semi-structural liners, where an inflated hose is placed in the pipe and cured or sealed in place using steam/hot air.
- Cured in place structural liners, which is the same as the cured in place semi-structural liners, but the lining is reinforced with fibreglass to provide structural strength (the liner does not rely on the host pipe).<sup>7</sup>

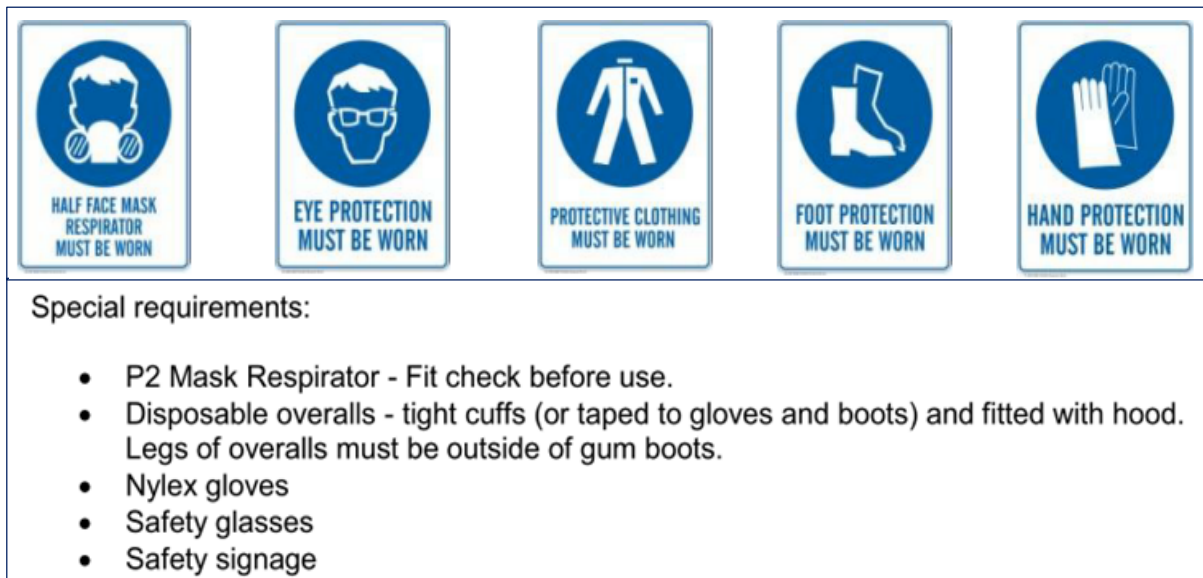
Figure 4.1: PPE that must be worn, and special requirements that must be complied with, when cutting AC pipe or in the vicinity of cutting of AC pipe.

- Wear a respirator fitted with an approved respiratory P2 Filter

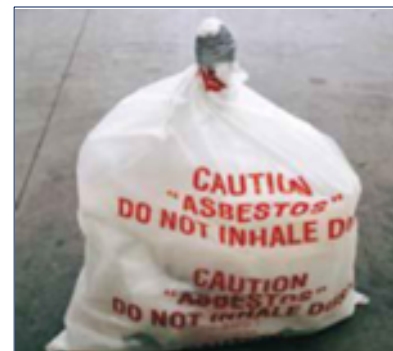
Photo: AC disposal bag, goose necked and sealed.

6. Replace the pipe.
7. Wash down tools, equipment and PPE (if for re-use).
8. When complete, place PPE in AC disposal bag (see photo), which is taken to a licenced landfill.

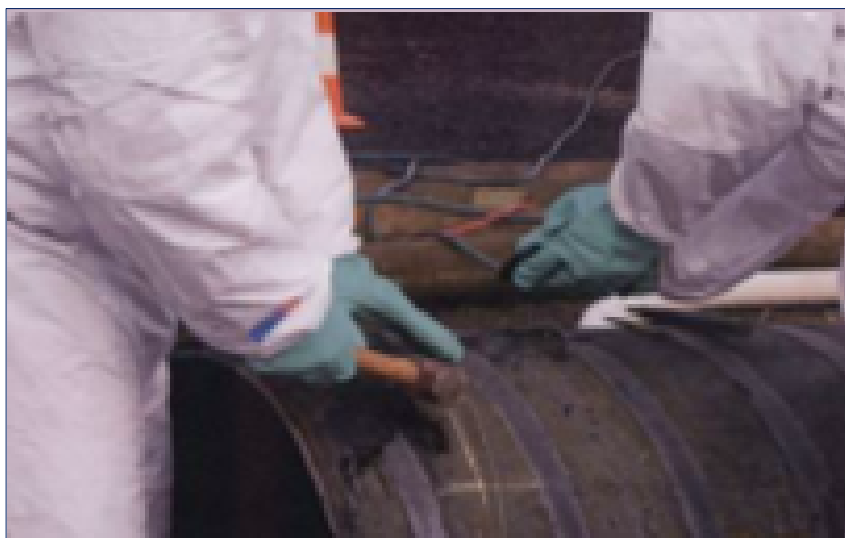
Photo: The hammer and chisel method used to remove asbestos from MSCL pipes.

1. The pipe is taken out of the ground and removalists coat the area on the pipe to be removed with a mix of water/PVA or water-based paint.
2. They then barricade the area and place a 200-micron sheet or bag under section of the pipe to be removed to capture waste as it is chipped away from the pipe.
3. The asbestos is then removed by chipping it away using a hammer and chisel (see photo below). If the wrapping is not totally removed from the pipe, the area is rasped to ensure all wrapping material is removed.

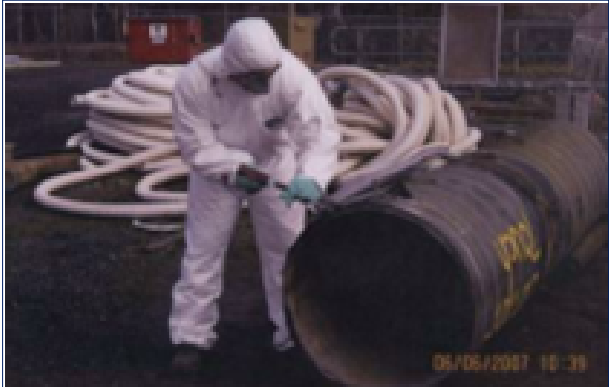
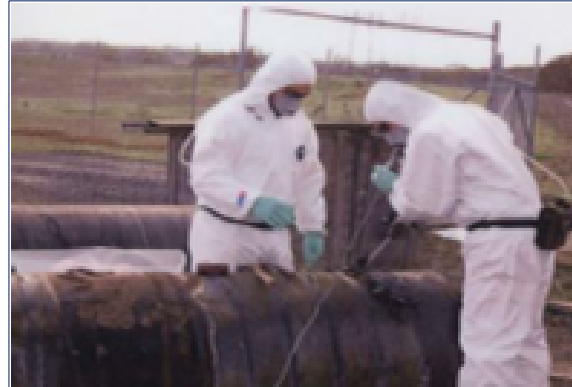
Photos: AC pipe removalists undertaking removal works.

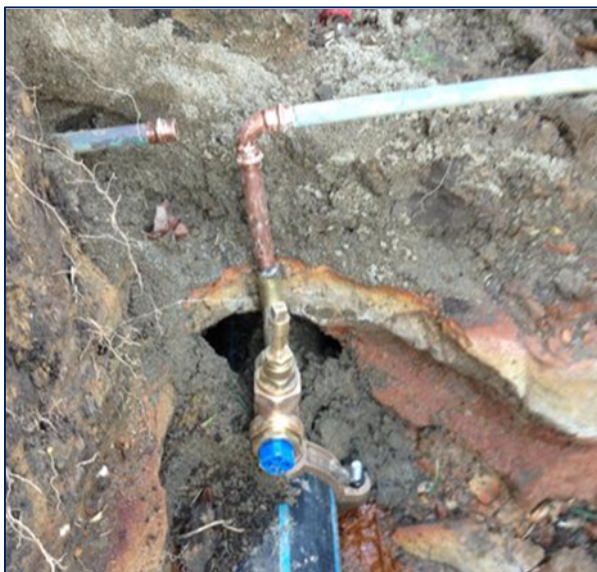
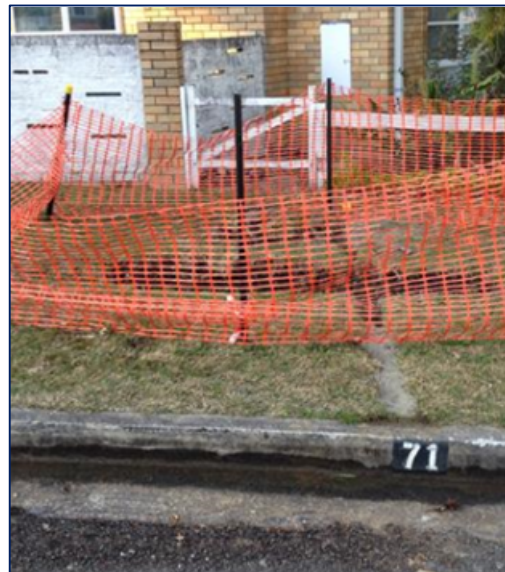
Photos above: The worksite where Shoalhaven Water removed an AC pipe and replaced it with a new water main.

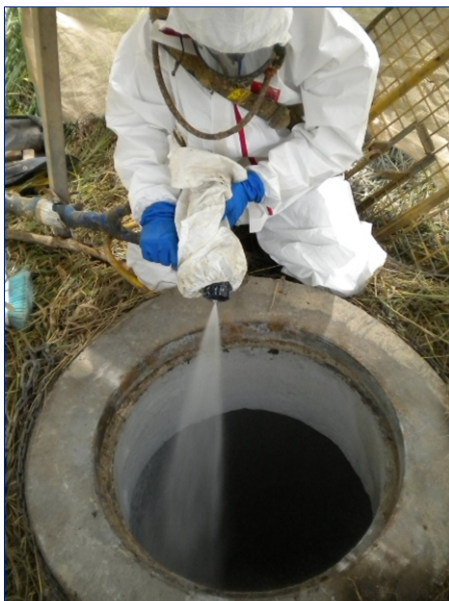
Photo: Manholes, showing signs of deterioration, being repaired. A special coating is applied to restore them to original condition.

In the first instance, cameras are used to assess the sewer network, identifying areas of degradation that are subsequently targeted for relining. The remediation work is then undertaken across two phases. Firstly, manholes showing signs of deterioration are sprayed with a special coating to restore them to their prior level of performance. This method can be done directly into the manhole without the need for excavation and removal.

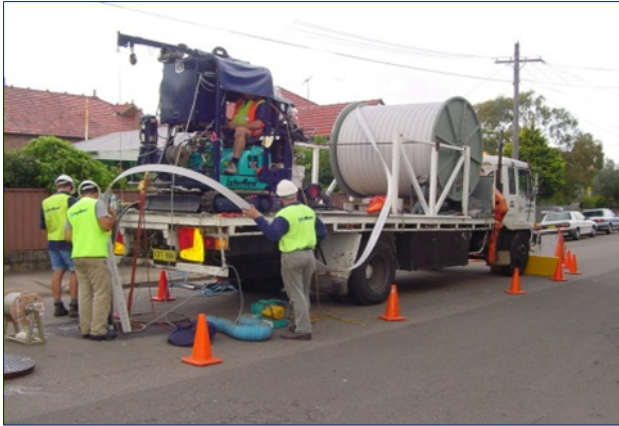
**Photo: AC pipes being repaired via trenchless technology.**

Secondly, pipe areas targeted through the camera investigation are repaired using innovative trenchless relining methods to correct faults, rather than being replaced. This is a ‘no-dig’ and cost-effective way of renewing the pipe. In most cases, the new pipes are formed on site by taking a continuous strip of profile and spirally winding it inside the damaged pipe, forming a new, watertight structural pipe within the host pipe.
