Access Canberra/Workplace Protection/WorkSafe ACT – Last Mr Fluffy premises containing bulk loose fill asbestos in ACT remediated

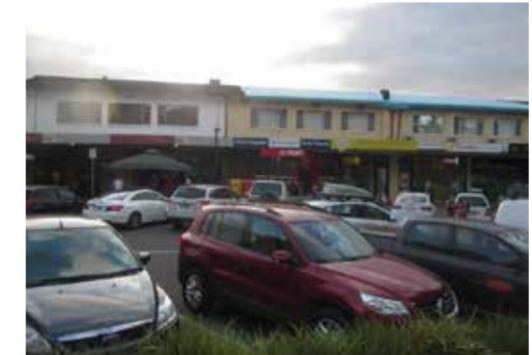
Figure 25: Ainslie shops in Edgar Street – left to right – shop 1 – 3 – 5

In 2017 WorkSafe ACT engaged with the owner of number 1 Edgar Street to consider options for the safe removal of the asbestos at his expense. Testing was conducted on the roof spaces adjacent to number 1 and it was found that the fibres had migrated to the roof cavity of numbers 3 and 5 Edgar Street, with no residual find of asbestos in number 7 Edgar Street (Figure 25).

- The bulk loose fill asbestos was removed during 2017 from the roof space at number 1 Edgar Street.
- During June/July 2018 the roof space of numbers 3 and 5 Edgar Street underwent a full environmental hygiene cleansing.
- The entire roof space of the building, from numbers 1 to 7 Edgar Street, had full replacement of electrical wiring, plumbing and insulation. The roof tiles were replaced to prevent the water egress into the building.
- The entire building has been resealed with an Asbestos Management Plan now in place to ensure no intrusion into the wall cavities are made for future renovations.

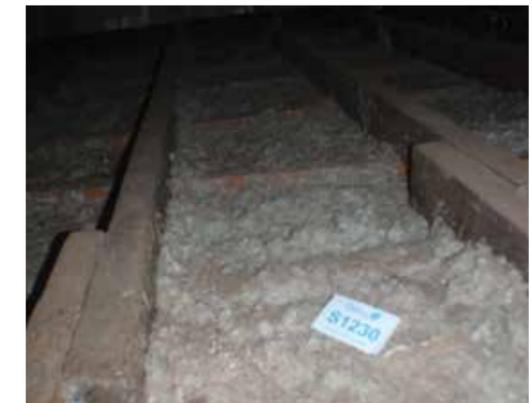
Figure 26: Photo in the roof cavity of shop number 1 Edgar Street – Ainslie Shops

Since the early 1990s the presence of loose fill asbestos (Mr Fluffy) was confirmed to be in place in the roof cavity of number 1, Edgar Street, Ainslie (Figure 26). At the time the premises was leased to a business and was deemed commercial.

The roof cavity of number 1 was the only known location in the ACT that still contained loose fill asbestos in bulk form. It was a government imperative to remove the asbestos for the safety of the community. Advice from consultants Robson Environmental confirmed that there would be a major safety concern in the event of an adverse weather event or fire in the building.
